Fishway Assessment and Cost Analysis Report

ROYAL RIVER, YARMOUTH ME

**PREPARED FOR THE NATURE CONSERVANCY
FINAL – JULY 2017, REVISED JANUARY 2018**

**INTER-FLUVE
P.O. BOX 236
DAMARISCOTTA, ME 04543**

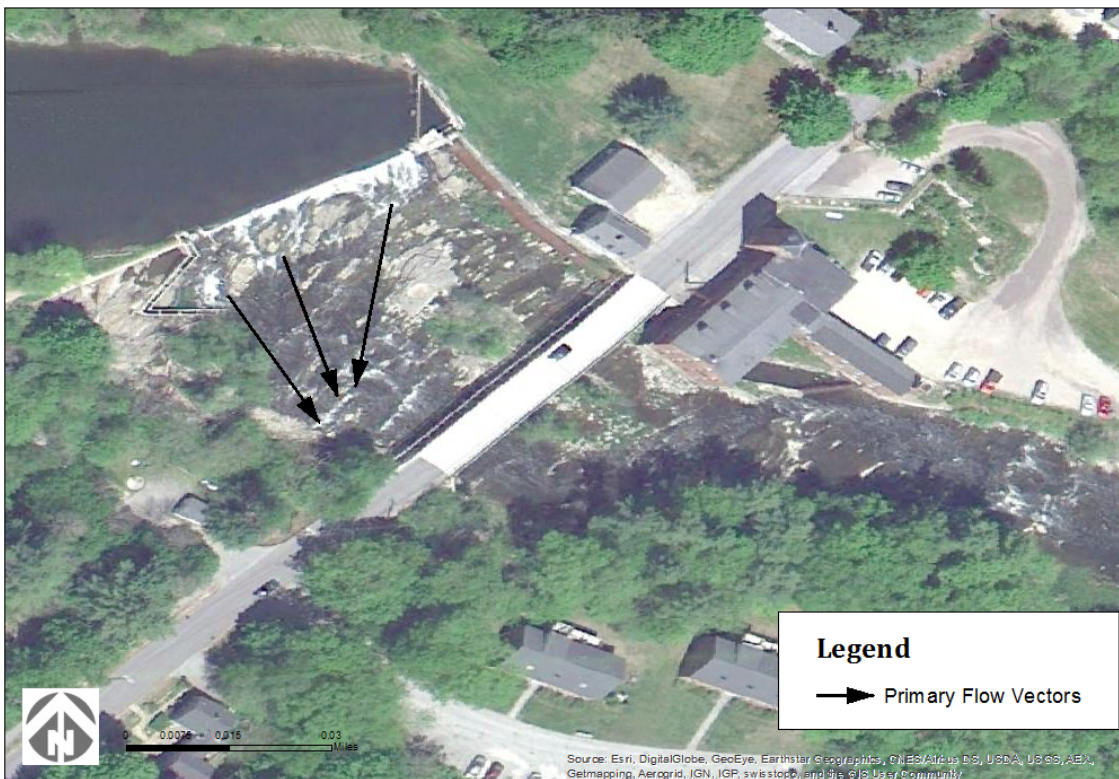
Upstream of the tailrace, fish encounter the beginning of the ledge outcrop and the bridge. Based on the review of the available high resolution aerial photography and previous topographic survey results (Titcomb 2013), the predominant flow patterns downstream of the spillway over the ledge outcrop tend to orient to the river right margin, with several primary streams converging in the vicinity of the fishway entrance (Figure 8). During the highest flows, there is a secondary flow pathway on river left but based on review of the aerial photos, this appears to be a shallower, less substantial flow alignment. As fish migrate closer to the fishway entrance, however, they will encounter several competing signals during many flow conditions, with the exception of the lowest flows (Figure 7 and Figure 8). These patterns may present challenging far-field attraction conditions for upstream migrating fish over a notable portion of the fish passage operational range. This trend is exacerbated by the relatively modest discharge that is able to be passed through the fishway while still operating in the target flow condition for upstream passage (discussed in more detail below).

Figure 8: Site map of the Bridge Street site indicating primary flow vectors. Date of imagery is May 16, 2010. Flow direction is left to right.

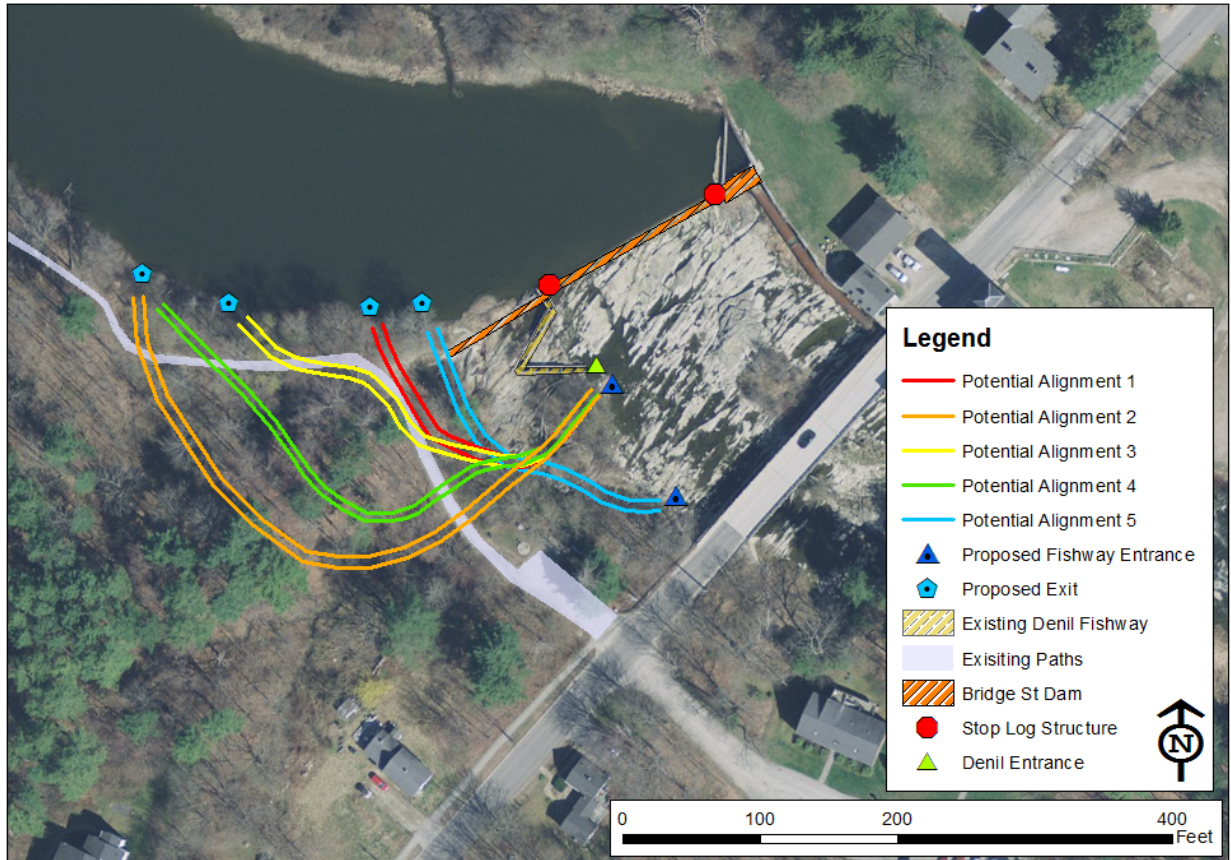
Additional design development would be required to optimize the nature-like bypass approach. However, several potential alignments were identified (Figure 12), which range in average channel slope from ~2.5-7% (Table 12). Ideal nature-like average channel gradients fall in the 2% to 3% range or less, with a maximum of up to 5%. Flatter channel slopes will facilitate passage by the broadest range of target species. These potential alignments would accommodate 100% of low fish passage flows (95% exceedance quantile), 60% of median fish passage flows (50% exceedance quantile), and up to 20% of high fish passage flows (5% exceedance quantile). All alignment options would make use of natural channel features such as pools and riffles, step-pools, and resting boulders to dissipate energy and create a diversity of flow patterns that fish would utilize as they ascend the channel, similar to native flow patterns in a natural stream. The differences between the alternative alignments are generally simply related to their overall lengths. With a longer channel alignment, the associated slope will be flatter. With flatter slope, velocities and hydraulic forces are reduced, leading to a higher degree of fish passage performance. The diversity of velocity and depth within the nature-like fishway would result in sufficient opportunity to increase the success rate of upstream passage (Aaerestrup 2003; Calles and Greenberg 2005).

The potential Bridge Street Dam bypass channel would connect into the main channel upstream and downstream of the dam on river right. Several of the alternative alignments would require construction on the Town of Yarmouth parcel as well as an adjoining private parcel adjacent to the right dam abutment. Downstream constraints for the alignment of this alternative include sanitary sewer infrastructure 125 feet downstream of the dam on river right. Several of the alternative alignments shown in Figure 12 cross the existing footpath adjacent to the river, which would require reconfiguration of a short stretch of the path, and possible addition of a footbridge. For the purposes of the cost analysis, a 481-foot-long nature-like bypass channel was assumed, which represents the lowest slope option listed in Table 15. This is a conservative assumption, as this also results in the longest length of channel construction and hence the greatest estimated construction cost among the alternative alignments shown.

Figure 12: Potential alignment options for the nature-like fishway alternative at the Bridge Street dam Location. Potential nature-like fishway construction constraints are included, such as pump station and drainage outfall locations.
