# STROUDWATER RIVER WATERSHED

## SURVEY REPORT

Cumberland County Soil & Water Conservation District

June 2014

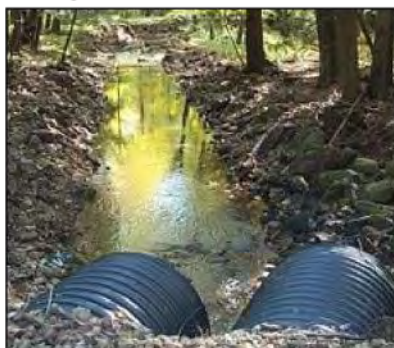
**Misaligned Culvert**

Culvert was not placed in same direction as stream flow. This can cause bank scouring.

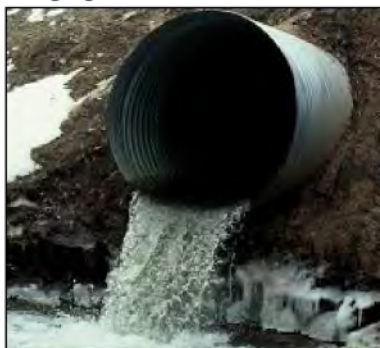
**Hanging Culvert**

Culvert outlet is above water line. This impedes fish passage and causes stream bed scouring, cause bank scouring.

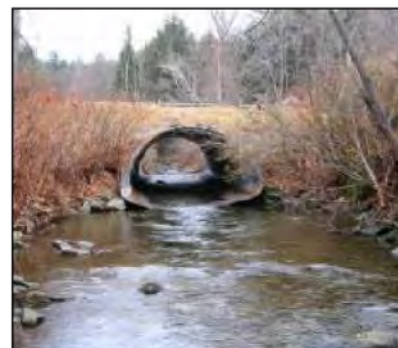
**Undersized Culvert**

Very common. Culvert diameter is much smaller than stream width. This can cause stream bank scouring and road washouts.

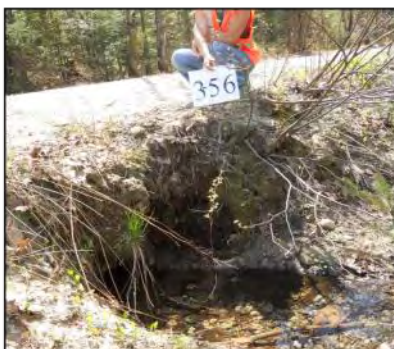
**Too Short Culvert**

Culvert is too short causing road shoulder to cave around ends of culvert.

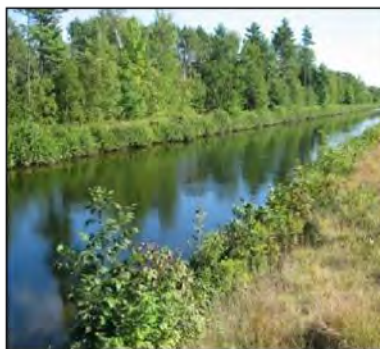
**Stream Channel Alteration**

Stream has been altered by man-made means. Typically straightened to quickly drain adjacent land. Can also include riprapping or altering stream bank and channel.

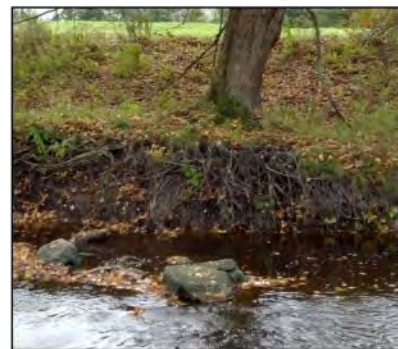
**Stream Bank Undercutting/Erosion**

Changes in water flow levels, velocity, and patterns that cause bank erosion. Typically noticeable by the presences of exposed roots.

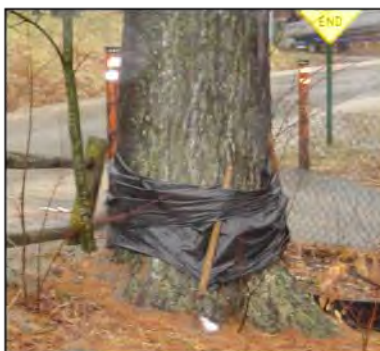
Inadequate: Sediment barriers are not present, are improperly installed, or have a gap in which sediment is or can wash off site.
