# Tidal Restriction Restoration at Wallace Shore Road

## 2015 Monitoring Report: Year 1 of 5, Post-Construction

Submitted: March 1, 2016

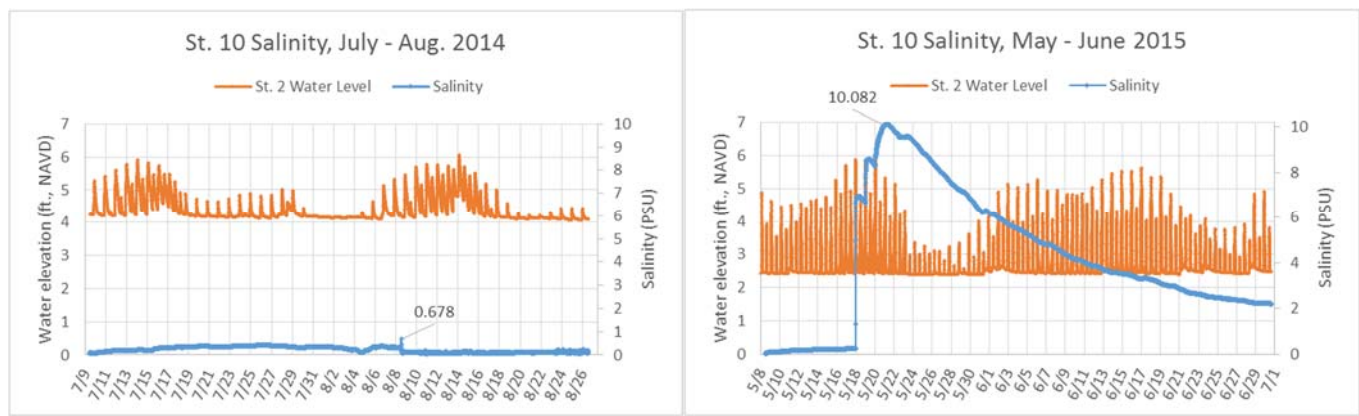
Figure 13. Comparison of pre- and post-project salinity levels at St. 10 with water levels at St. 2.

Tables 9 and 10 summarize the mean, minimum, and maximum salinity levels for surface water at Stations 1 and 2, and groundwater at Station 10. Mean salinity levels were higher at Stations 1 and 2 in 2014 (Table 9) than at the same locations in 2015 (Table 10). In 2014, salinity levels at Station 10 were near zero for the deployment period, but in 2015, salinity levels reached a high of 10.1 PSU (standard salinity units), despite the fact that overall site salinity was lower downstream, and there was a much lower documented HOW in 2015 than in 2014 (see Section 3.8.3). Figure 13 plots pre- and post- project salinity at Station 10 with water levels at Station 2 to illustrate the effect of high water levels on salinity upstream. Spring tides did not affect salinity levels at Station 10 in 2014, but did in 2015, indicating that tidal water moved upstream of 9078.

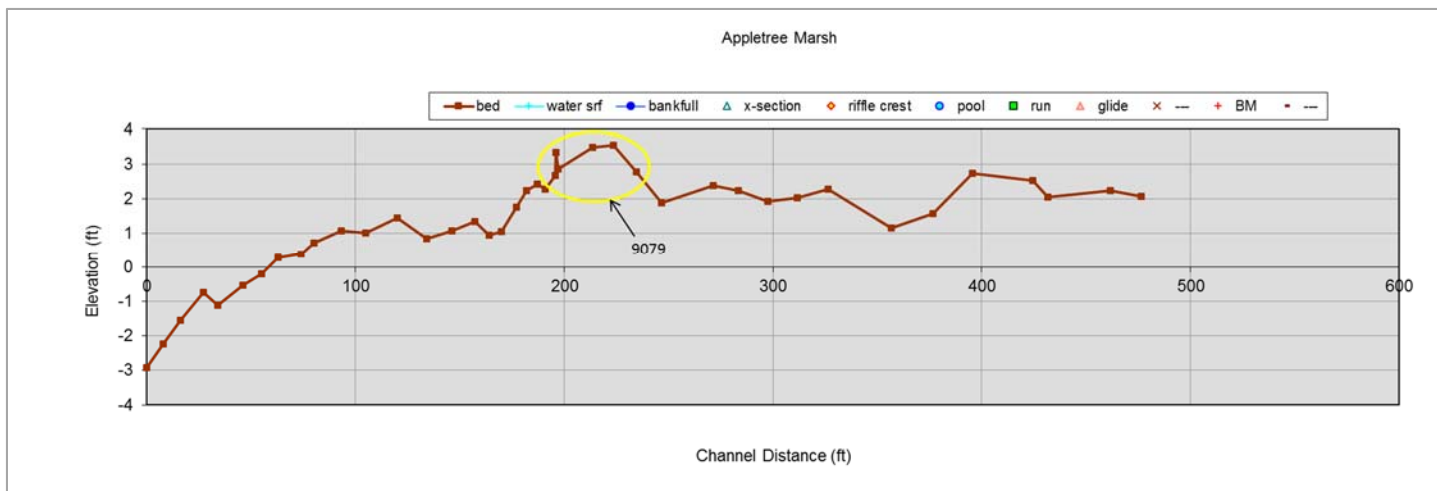
Figure 16. Pre-project longitudinal profile of 9079 (2012). Mecklenburg 2006.

CBEP staff surveyed channel cross sections at Stations 1-9, as well as longitudinal profile through the construction areas, pre-project and again in 2015. Data were entered into the *Reference Reach Spreadsheet*<sup>1</sup> for comparison. Fig. 16 plots the longitudinal profile of 9079 based on data collected in 2012. The profile illustrates the perched crossing (9079) at 200 feet, with accumulated sediment 50 feet upstream of the culvert outlet functioning as a grade control that impounded surface water upstream. Fig. 17 plots the profile of the channel approaching 9078 from downstream.

The channel bottom at 9079 is consistent with the channel grade upstream and downstream, and the accumulated sediment upstream is no longer evident. A series of shallow pools remains immediately downstream of 9079, and has formed immediately upstream in response to gradual movement of sediment. A small head cut was observed a little more than 400' upstream from the bay, with the channel bottom relatively flat until getting shallower between Station 8 and 9. The channel bottom at 800' (Fig. 18) has dropped by approximately 1' from the 2012 survey (50', Fig. 17). Further upstream, the channel becomes extremely shallow approaching 9078, where the slug of coarse-grained sediments (evident in both Fig. 17 and 18) sits on the marsh surface, resulting in a very shallow braided channel below the outlet of 9078. The sand is believed to have been deposited in this location during a culvert blow-out prior to any discussions about a restoration project. Local residents described a portion of the road bed washing onto the downstream marsh along with the culvert. Immediately upstream of the slug, and immediately downstream of the culvert outlet, is the area excavated during culvert installation. Here, water is pooled behind this grade control through the culvert into the excavated area upstream, above which a defined channel is no longer visible. This issue is discussed further in Section 4.2.

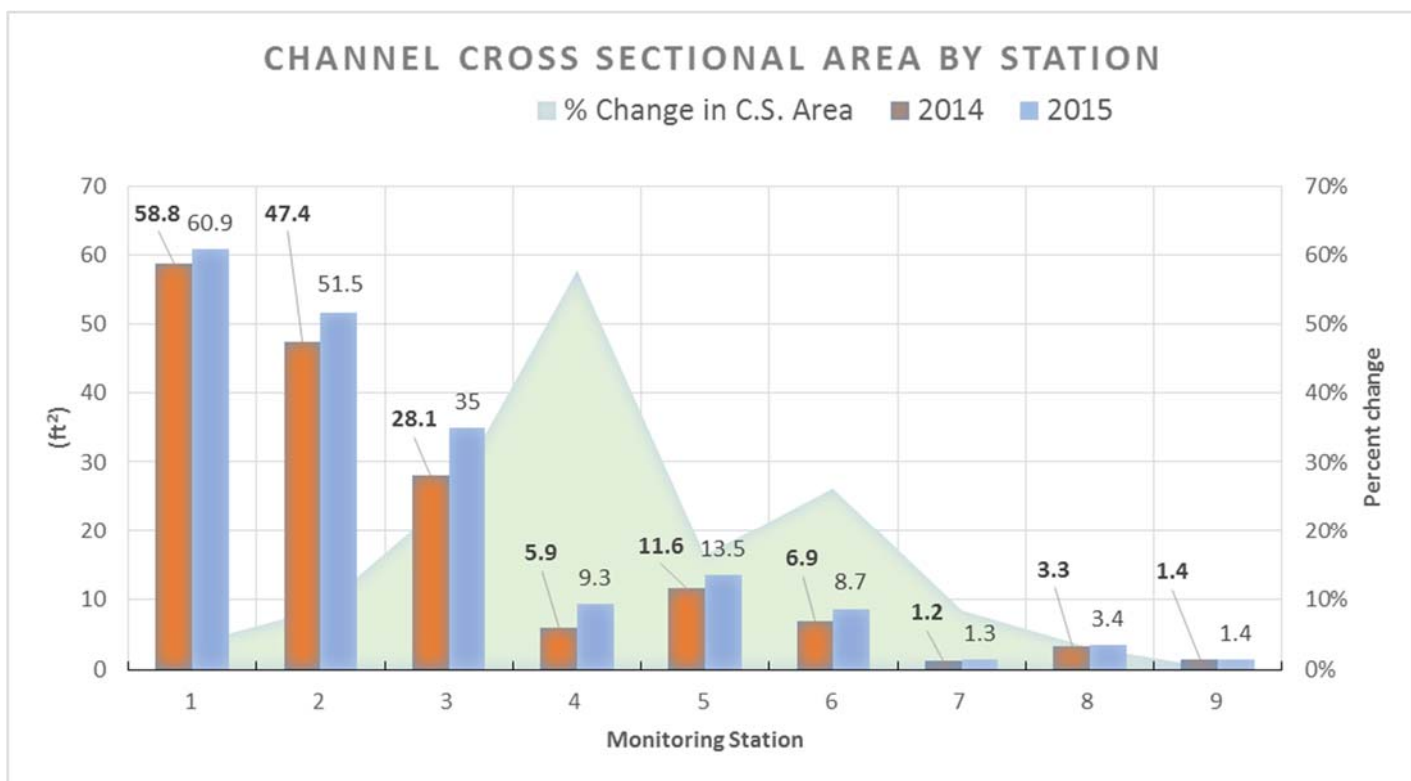
Figure 20. Comparison of channel cross sectional area pre- and year 1 post-project.

By percentage, the greatest increase in channel cross sectional area from pre-project to 2015 occurred at Station 4 (57.6%; Fig. 20). By volume, the greatest increase was measured at Station 3 (6.9 ft.<sup>2</sup>).

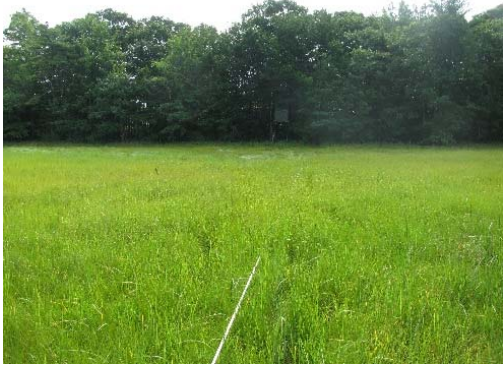
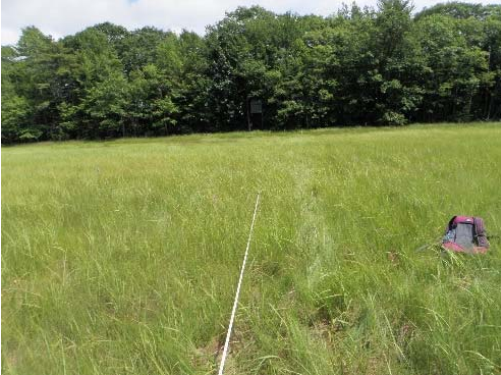
PRE-PROJECT	POST-PROJECT (YEAR 1)
Transect 4. (L – 7/17/2014; 7/14/2015); view E from channel to upland.

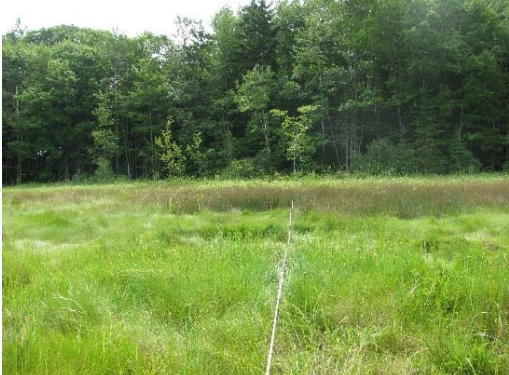
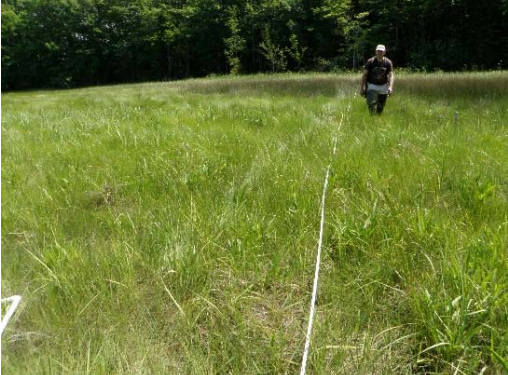
Station 5. (L – 7/17/2014; R – 7/14/2015); view E from channel to upland.

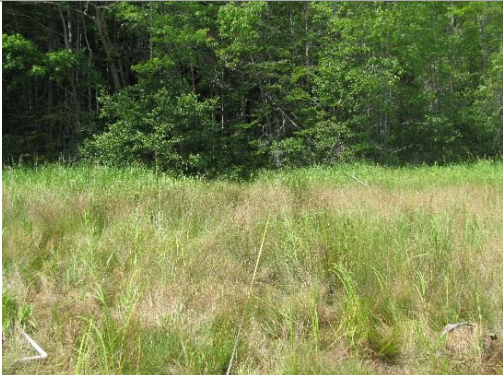
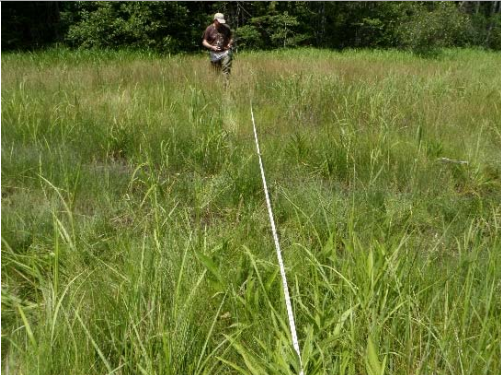
Station 6. (L – 7/17/2014; R – 7/14/2015); view E from channel to upland.

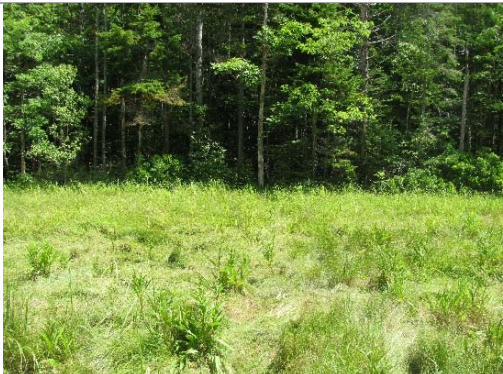
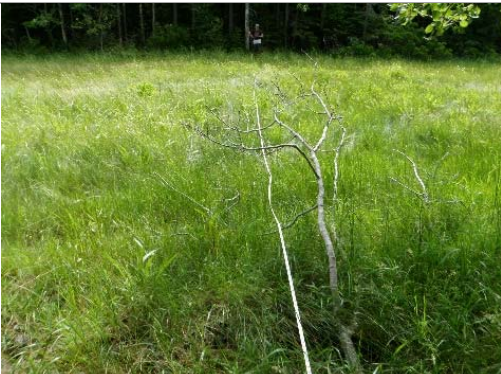
Station 7. (L – 7/17/2014; R – 7/14/2015); view E from W end of transect.

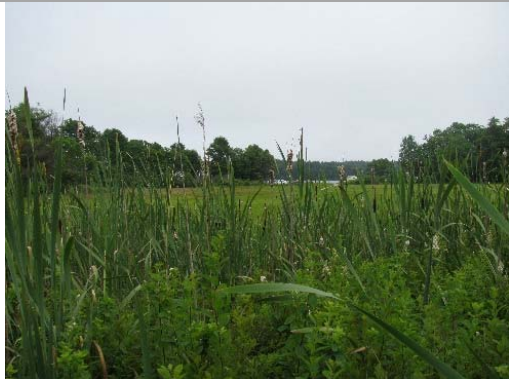
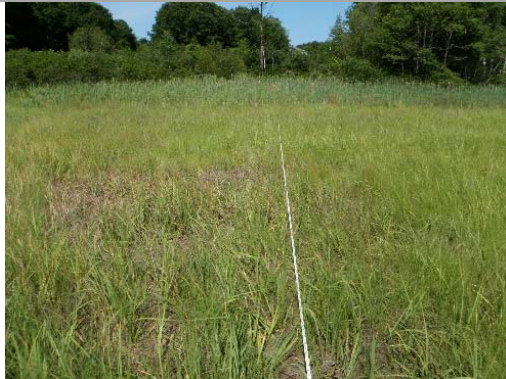
PRE-PROJECT		POST-PROJECT (YEAR 1)	
Transect 8. (L – 7/15/2014; 7/16/2015). L - view E from upland to channel; R - view W from channel to upland.

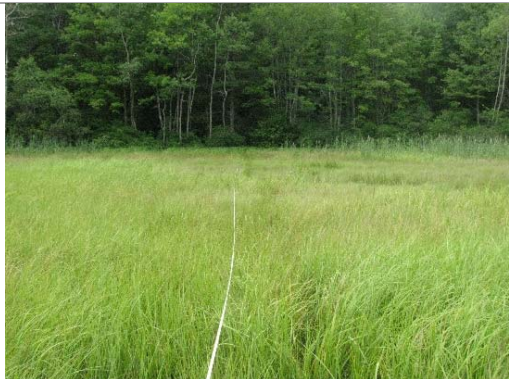
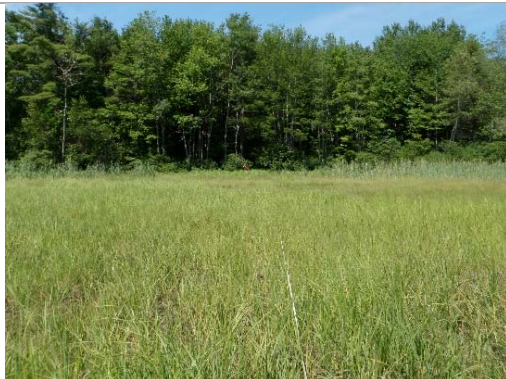
Station 9. (L – 7/15/2014; R – 7/16/2015). View W from channel to upland.

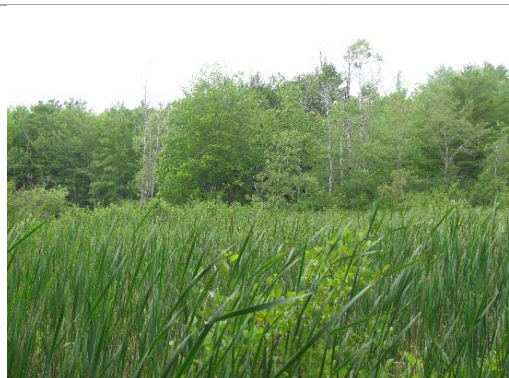
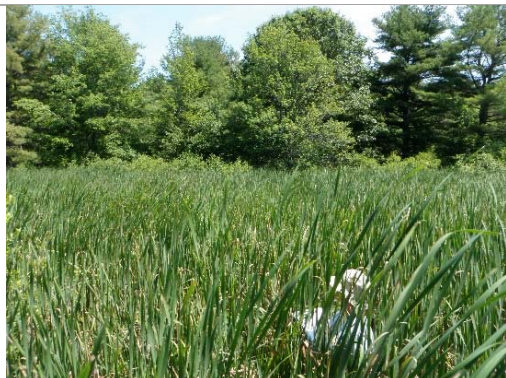
Station 10. (L – 7/15/2014; R – 7/16/2015). View E from W end of transect.
