Casco Bay Watershed Fish Barrier Priorities Atlas

Casco Bay Watershed

Fish Barrier Priorities Atlas

March 2012

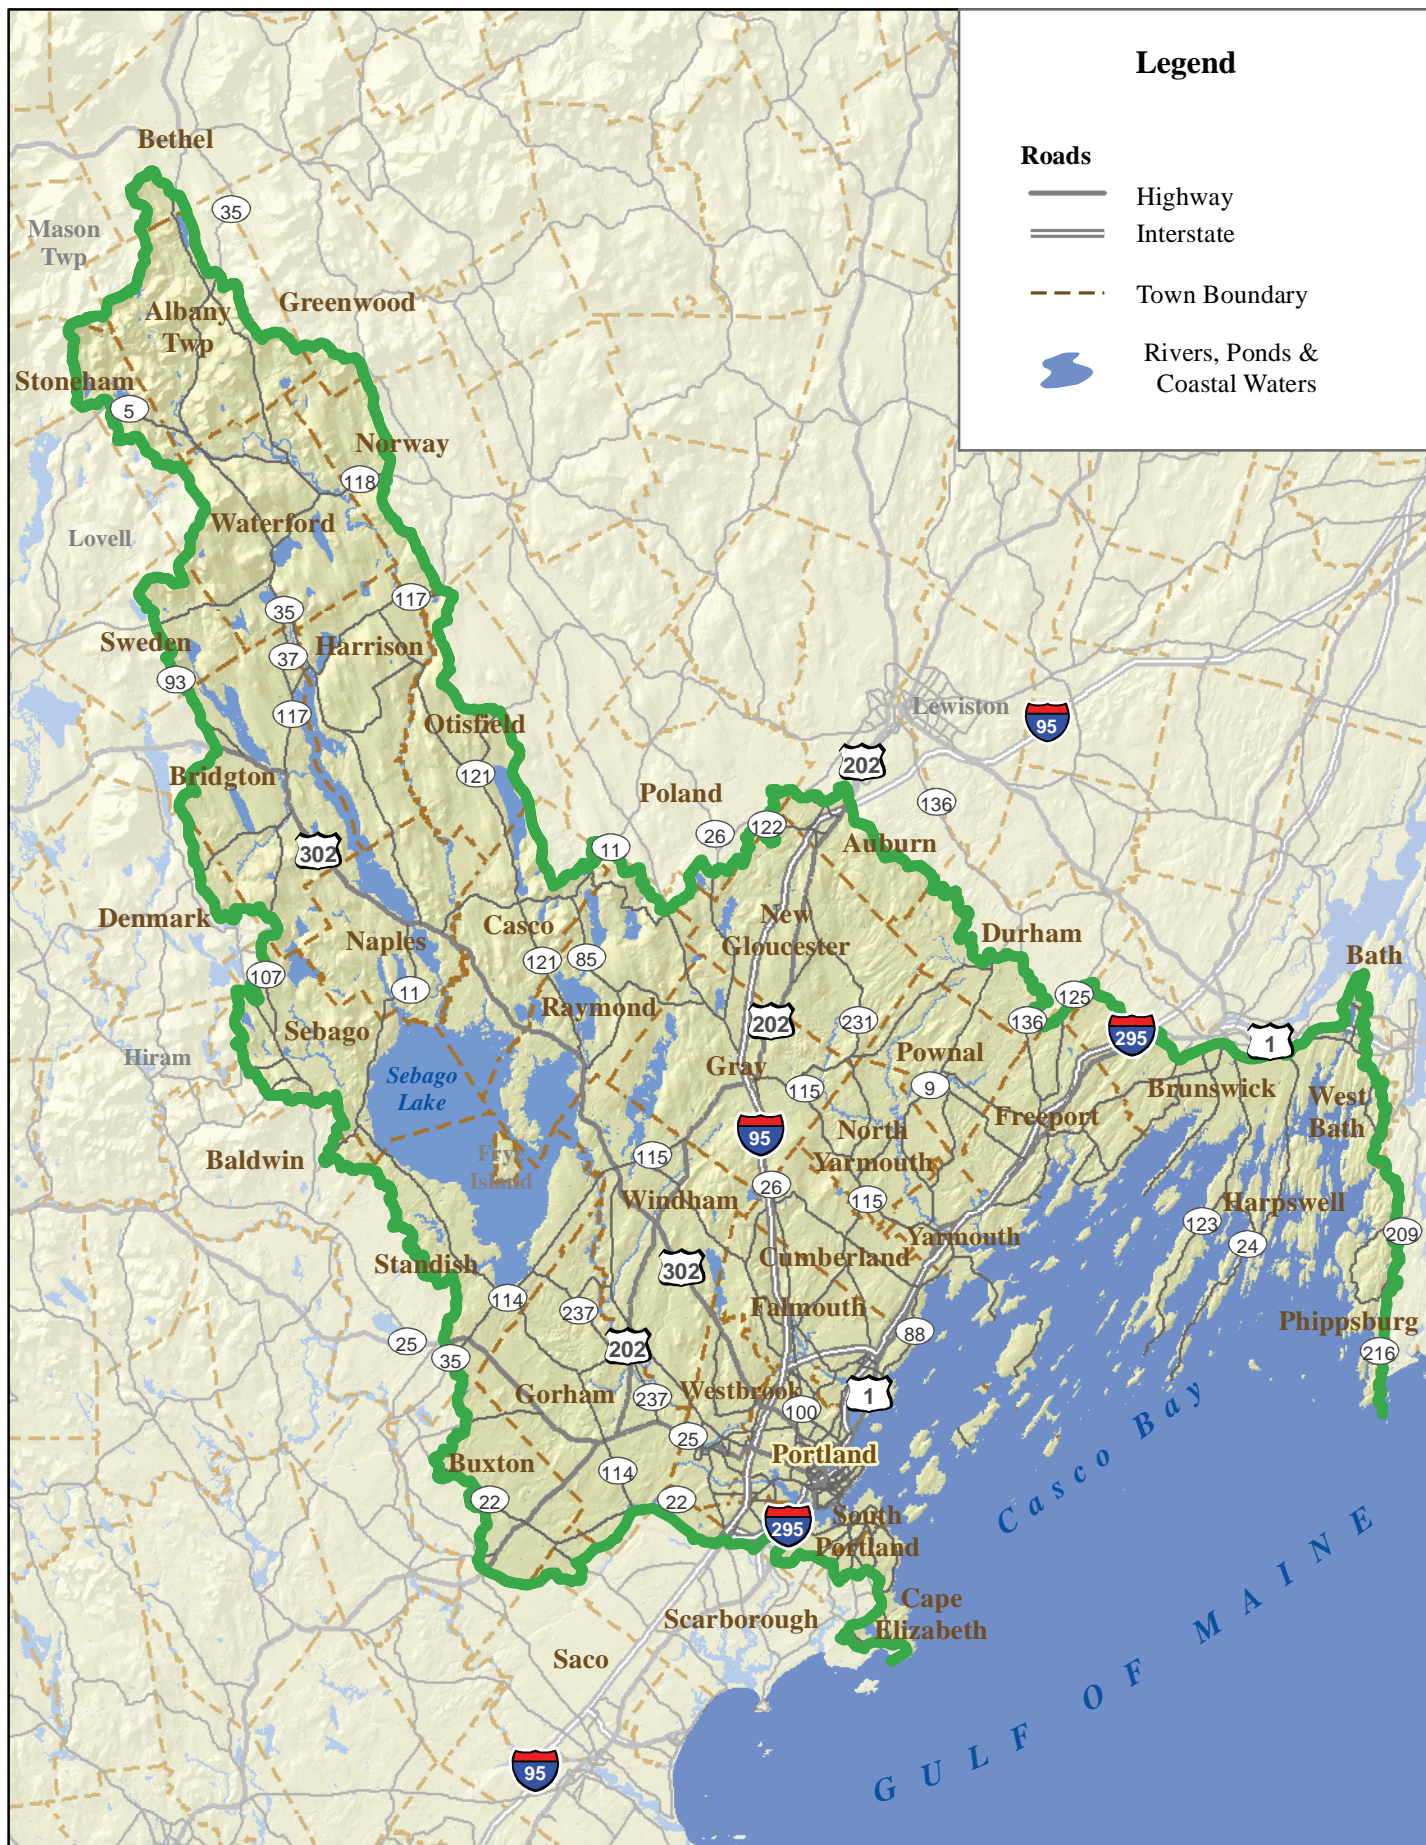
Index Map

Casco Bay Barriers by Town

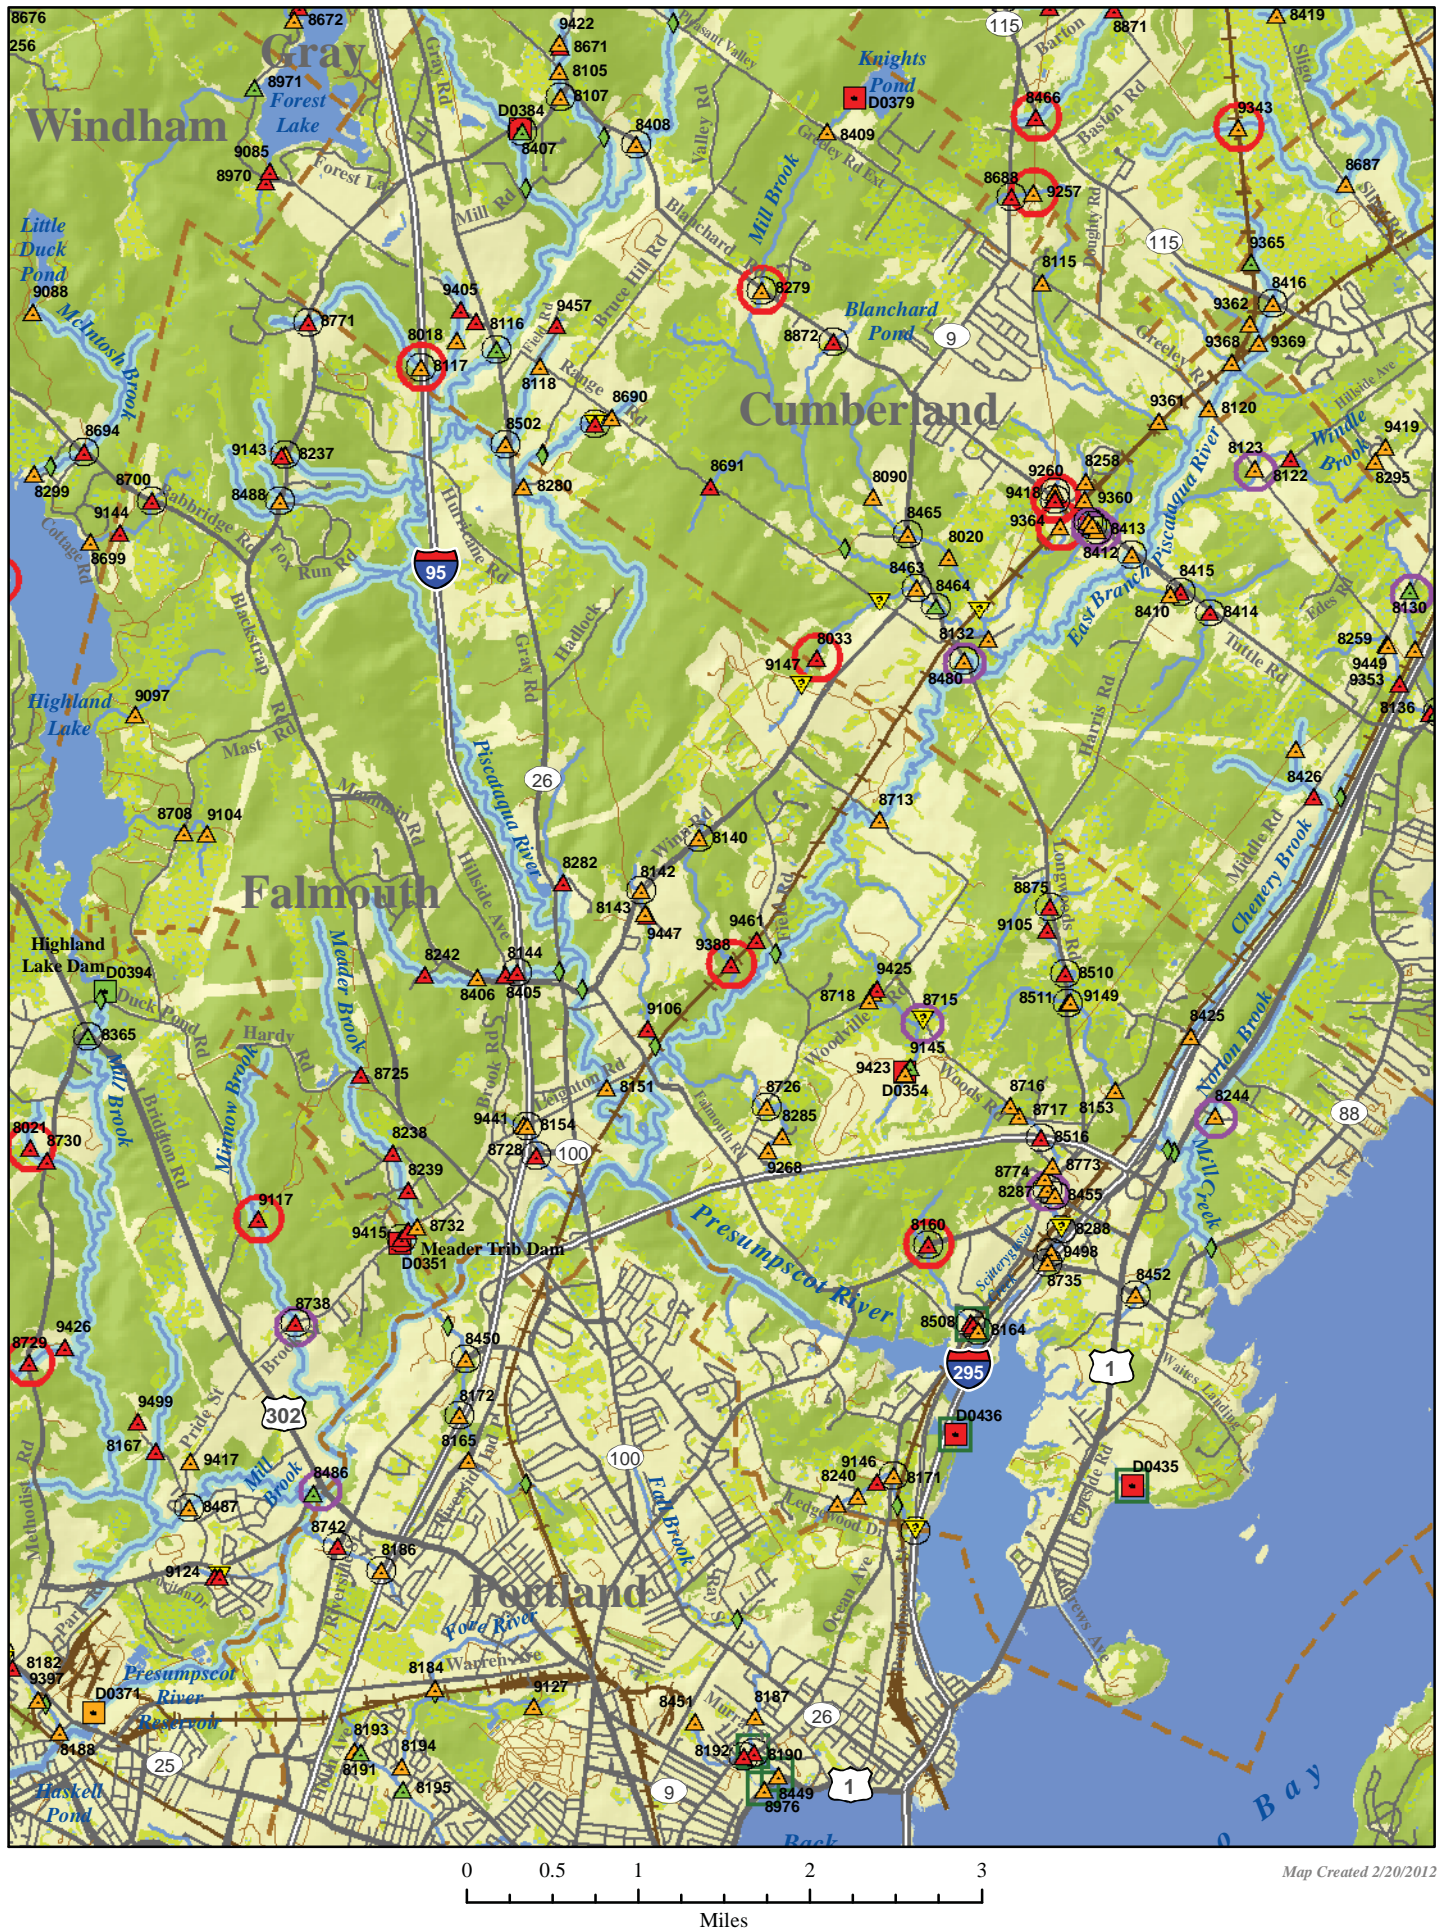
Falmouth

Casco Bay Barriers by Town

Road-stream crossings are shown with SiteID numbers to help identify them in the barrier database. Dams, in most cases, have labels both of SiteID and the dam's common name, if one is known. *Severe* barriers are defined as those road/stream crossings where fundamental physical barriers exist at either the inlet or outlet of the crossing, including inlets or outlets "perched" above the stream channel, and inlets blocked at least 50%, usually by debris. *Potential* barriers cover a wide spectrum of road-stream crossing situations where fish passage problems are likely to exist at some flows for some species or age groups of fish, and passage of other aquatic organisms such as amphibians and macroinvertebrates is likely also limited. Sites that were inaccessible to survey crews, and therefore not surveyed, are shown as unsurveyed, but are included in our analysis as *Potential* barriers. Dams are classified by whether or not they have effective facilities in place to provide upstream fish passage. Natural barriers, including waterfalls, debris jams (including woody debris or rock and fine sediments), and beaver dams were assessed when in close proximity to surveyed crossings and dams, and are mapped as well.
