Casco Bay Watershed

Fish Barrier Priorities Atlas

March 2012

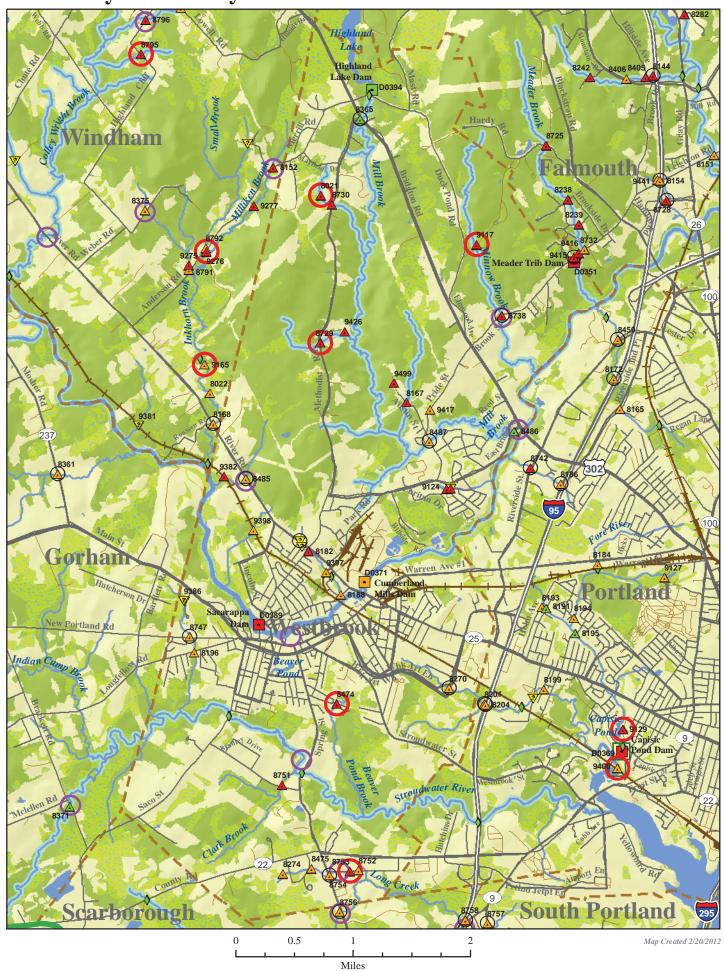
Westbrook

Casco Bay Barriers by Town

Road-stream crossings are shown with SiteID numbers to help identify them in the barrier database. Dams, in most cases, have labels both of SiteID and the dam's common name, if one is known. *Severe* barriers are defined as those road/stream crossings where fundamental physical barriers exist at either the inlet or outlet of the crossing, including inlets or outlets "perched" above the stream channel, and inlets blocked at least 50%, usually by debris. *Potential* barriers cover a wide spectrum of road-stream crossing situations where fish passage problems are likely to exist at some flows for some species or age groups of fish, and passage of other aquatic organisms such as amphibians and macroinvertebrates is likely also limited. Sites that were inaccessible to survey crews, and therefore not surveyed, are shown as unsurveyed, but are included in our analysis as *Potential* barriers. Dams are classified by whether or not they have effective facilities in place to provide upstream fish passage. Natural barriers, including waterfalls, debris jams (including woody debris or rock and fine sediments), and beaver dams were assessed when in close proximity to surveyed crossings and dams, and are mapped as well.

USFWS-GOMCP and CBEP staff consulted with state fisheries biologists to identify streams with important fish habitat, primarily for brook trout or Atlantic salmon, or both. These *priority streams* are highlighted on the maps. The scope of the road/stream crossing barrier assessment was limited to perennial streams, those with continuous flow year round. Although intermittent streams were not surveyed, fish using priority streams also rely on connectivity with intermittent tributaries at various times of year. There are likely to be additional barriers on important intermittent streams that have not been assessed.

The maps present data from Cumberland County Emergency Management Agency (CCEMA) and CBEP to show where flood hazards are likely to overlap with fish barriers. CCEMA, in cooperation with towns, has identified many road crossings as flood hazards based on past flood events. CCEMA sites are marked by purple circles, and do not always coincide with barrier survey sites because they may be located on intermittent streams or larger rivers crossed by bridges, which are generally passable for fish but may still entail flood hazards.
