As Impervious Surfaces Expand, Runoff Increases

Casco Bay Estuary
PARTNERSHIP

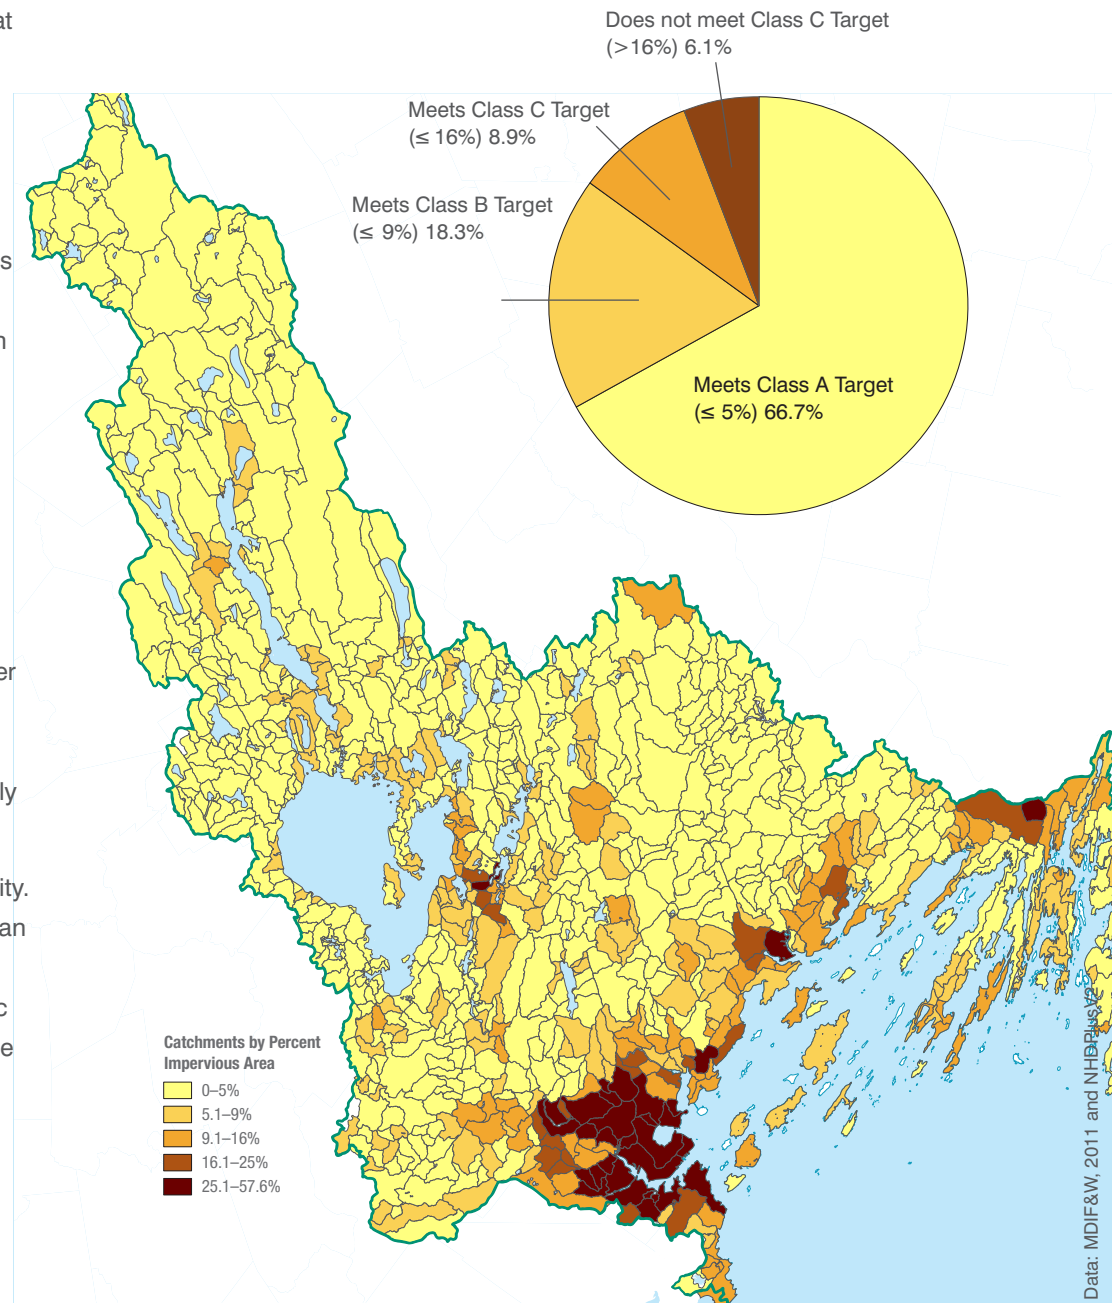
Percentage of Catchments in Imperviousness Target Classes

To assess local conditions, the Casco Bay watershed can be divided into smaller areas called catchments that reflect the way water flows across the landscape. As of 2007, two-thirds of the Casco Bay watershed was in catchments that met the recommended Class A threshold. Only 6 percent of the watershed was in urbanized areas with such high levels of imperviousness (more than 16 percent) that streams are unlikely to meet even Class C standards without significant investments to improve water quality.

no more than 5 percent of watershed area. The threshold increases to 9 percent for Class B streams and to 16 percent for Class C streams.
