Stormwater Management in Cold Climates – A Historical Perspective

Written by Daniel Holzman

Jaworski Geotech, Inc. 77 Sundial Avenue, Suite 401W Manchester, New Hampshire 03103

CASE HISTORY

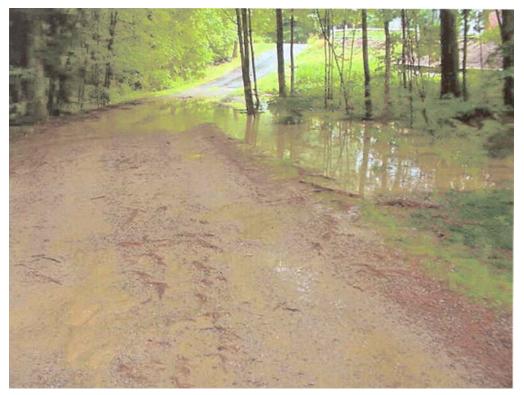
Figure 3: Flooding across Whippoorwill Lane August 2003

The summer of 2003 was significantly wetter than usual, including two short but intense storms in August. The storm of August 4, 2003 created flooding conditions at Whippoorwill Lane, including deposition of significant amounts of silt on the main subdivision road. Damage to septic systems, wells, basements, the fire pond, and the road itself resulted (see Figure 3). Flooding of this sort has apparently not been experienced in the close to 50 year history of Whippoorwill Lane, and occurred as a result of a storm estimated to have been less than 2 inches of rain in one hour.

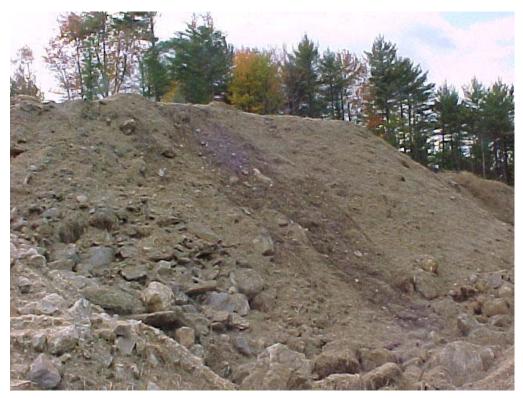
Figure 4: Disturbed soil off Burgundy Terrace. This photo was take after hydroseeding

- 1. The lots immediately uphill of Whippoorwill Lane had been severely disturbed, with minimal installation of silt fencing and haybales to retard flood flow and soil erosion (see Figure 4). The result was migration of large amounts of silt from the top of the hill to the bottom, directly onto Whippoorwill Lane.

We identified the need for additional artificially created detention storage on site. Three lots immediately uphill from Whippoorwill Lane along Burgundy Terrace have been identified as significant contributors of siltation and stormwater to Whippoorwill Lane, and we have proposed installation of two detention ponds and a series of stone lined channels to transport stormwater to the ponds. Construction of the ponds is challenging because the only area available within the lots is at the bottom of a hill currently graded to a nearly 1:1 slope. This limits the available area, and requires careful design of feeder channels to minimize the transport of silt that might otherwise fill the basin and reduce its effectiveness. Construction of the basins during the winter season is potentially difficult, due to the impossibility of establishing vegetative cover between the end of October and early April. We have considered use of geotextile fabric to stabilize otherwise erosion prone soils.

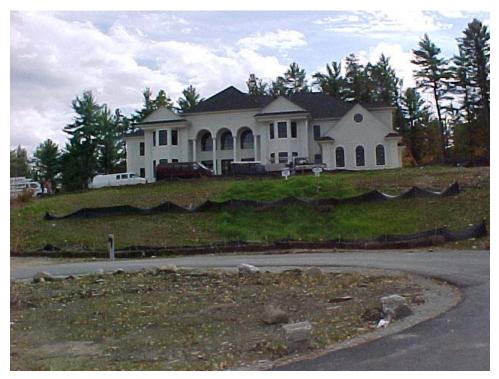
Figure 5: House with 8000 square feet impervious area on Burgundy Terrace

- 1. The estimated impermeable area per lot (exclusive of the public road system) was assumed to be approximately 4,000 square feet. Due to the large size of the majority of houses, the actual impermeable area per lot appears to be between 6,000 and 8,000 square feet.

- 4. The subdivision proved to be very popular, and multiple contractors have been building large houses simultaneously (see Figure 5). The result has been extensive soil disturbance occurring over as many as 15 lots simultaneously, leading to exposure of more acres of soil than anticipated in the erosion control plan. Erosion control measures have generally been ineffective and weakly enforced.

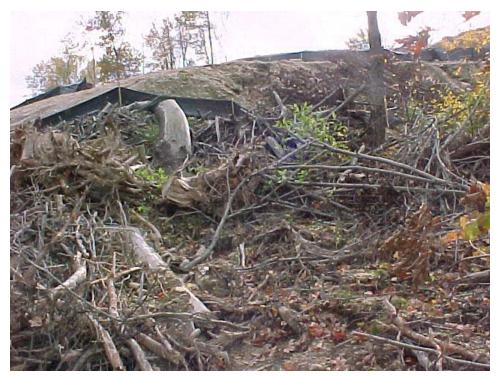
Figure 6: Erosion gulley in poorly stabilized soil

Poor erosion control practices during construction were a significant issue for this project. Temporary erosion control is often seen as an unnecessary expense by site contractors, who may hope that dry weather eliminates the need for extensive protective measures. Unfortunately, the wet summer of 2003 included a series of intense storms that carried silt and debris downhill to Whippoorwill Lane, leading to resident complaints (see Figure 6).

The Town of Bedford has no special regulations covering temporary erosion control during construction, and generally relies upon State and Federal regulation to minimize problems. Due to limited resources, there was little or no federal or state oversight on this project, and common erosion control techniques such as installation of haybales and silt fencing, excavation of temporary detention ponds, and use of erosion control fabric were not effectively utilized. Ultimately, the Town issued a cease and desist order on several lots preventing further construction, and arranged for hydroseeding of bare slopes along Burgundy Terrace prior to the end of the growing season (early October).
