# NEW MEADOWS LAKE BRUNSWICK and WEST BATH, MAINE

## Model Analysis of Expected Plant Communities Response to Potential Tidal Restoration Conditions

April 2007

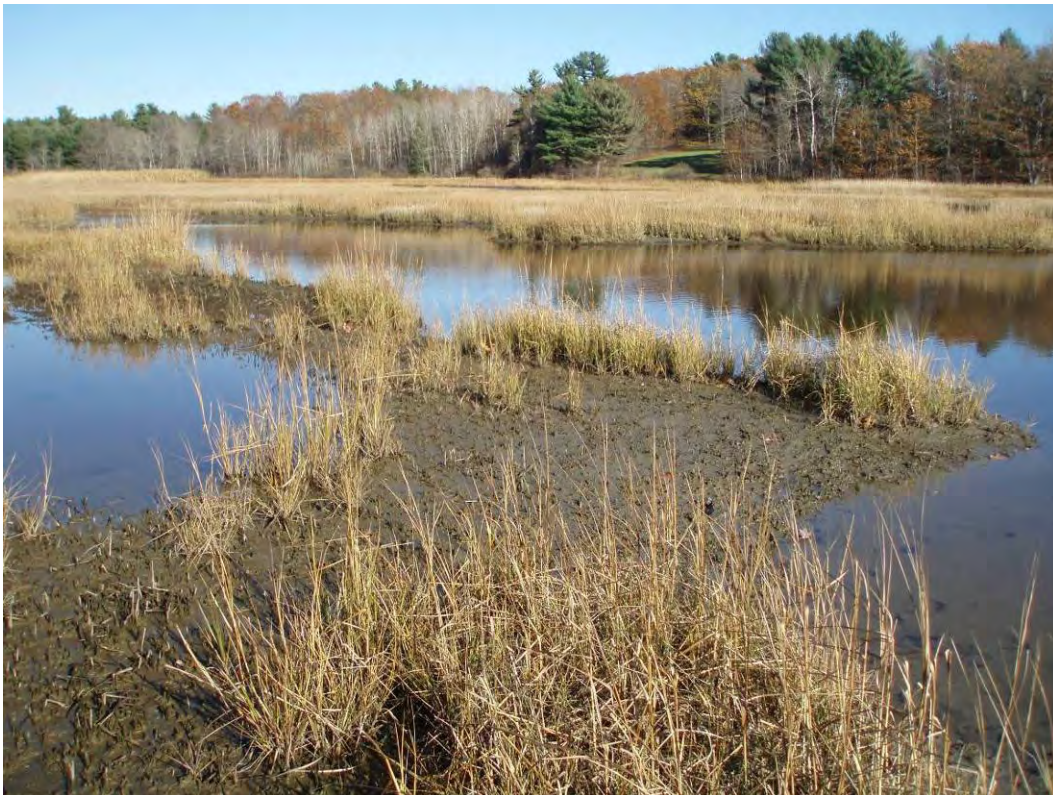
Photo 1. A cordgrass covertype located in the upper marsh that depicts a recent die-off for reasons unknown of saltwater cordgrass.

Salt meadow cordgrass and smooth cordgrass were generally limited to the fringes of Lower and Upper New Meadows lakes. These impoundments are steep sloped and very little habitat for these grasses remains. North of Old Bath Road, the *Spartina* Community is better developed and salt meadow cordgrass and smooth cordgrass occur in a mosaic pattern on islets and fringes along the edges of the water way (Photo 1). Freshwater cordgrass (*Spartina pectinata*) also occurs in small patches, typically near areas of fresh water intrusion, and as a border along the west branch of the waterway. Halophytes, e.g., black-grass rush, seashore saltgrass (*Distichilis spicata*), seaside goldenrod (*Solidago sempervriens*), and sampire (*Salicornia depressa*) were infrequently observed. This may have been due, in part, to the October timing of the survey, but salinity levels would also be a limiting factor.

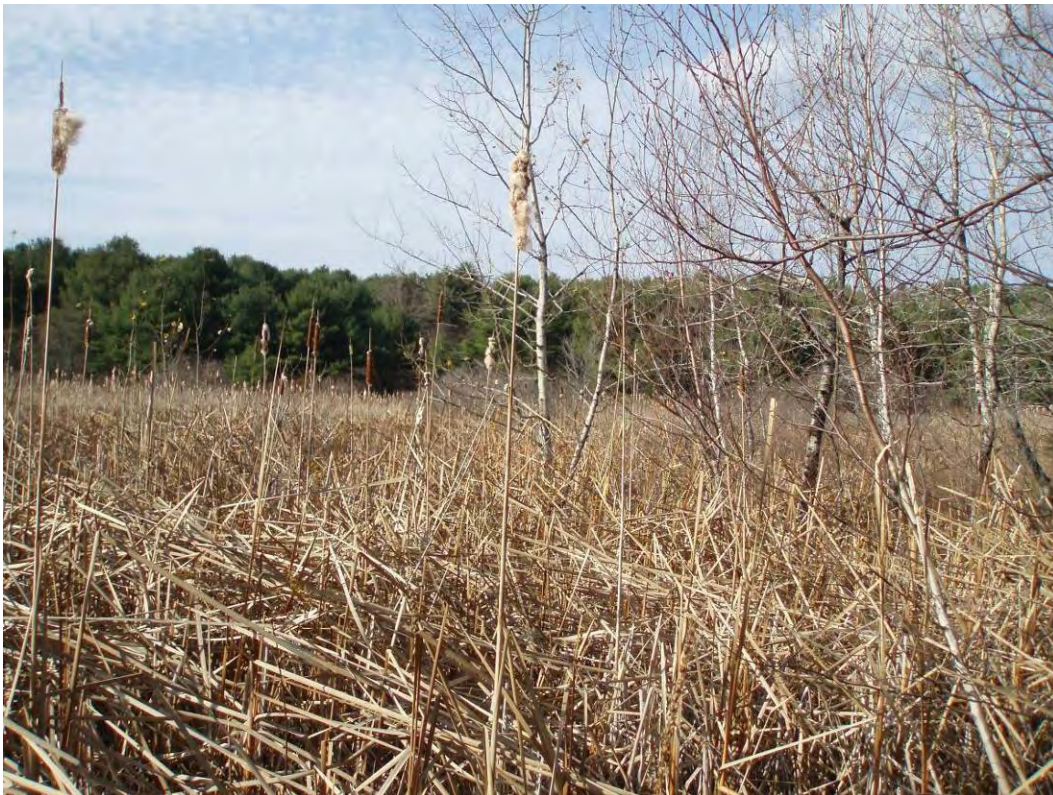
Photo 2. A plant community located in the upper marsh, west of the river channel that is dominated by cattail (*Typha* spp.).

Cattail dominated marshes are widespread around the Lower and Upper New Meadows lakes and cover larger areas north of Old Bath Road. Narrow-leaved cattail, common in coastal or brackish environments, was observed in the northern area and other cattails observed throughout the site probably included broad-leaved cattail (*Typha latifolia*) and the *Typha x glauca*<sup>4</sup> (Photo 2). Additional herbaceous species observed in the cattail marshes included Canada bluejoint (*Calamagrostis canadensis*), salt meadow cordgrass, marsh fern (*Thelypteris palustris*), sensitive fern (*Onoclea sensibilis*), alkali bulrush, and purple loosestrife. Shrubs observed in cattail marshes included meadowsweet (*Spiraea alba* v. *latifolia*), swamp dewberry (*Rubus hispidus*), and witherod (*Viburnum nudum*).

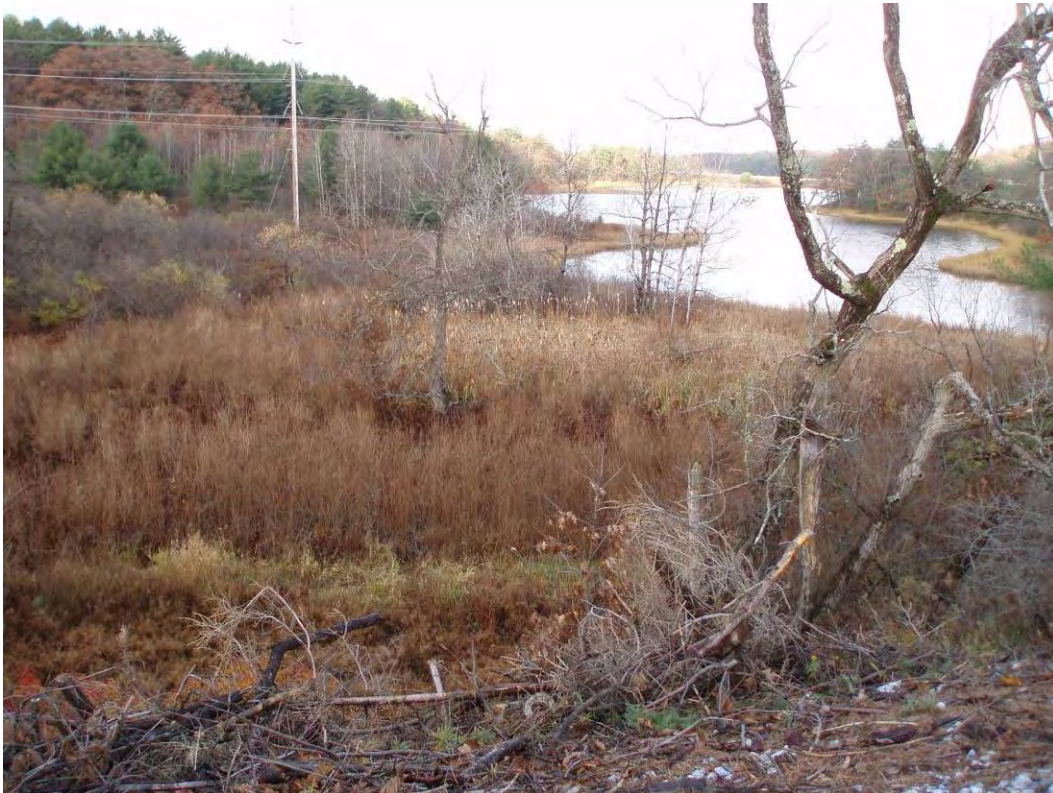
Photo 3. The single location of a purple loosestrife-dominated community located immediately north of the railroad bridge in the lower lake.

Purple loosestrife, an introduced invasive species, occurred, most commonly, as a component of cattail marshes and deciduous shrub swamps. Purple loosestrife was, however, a patchy dominant coertype just north of the railroad bridge on the west side of the Lower New Meadows Lake (Photo 3).

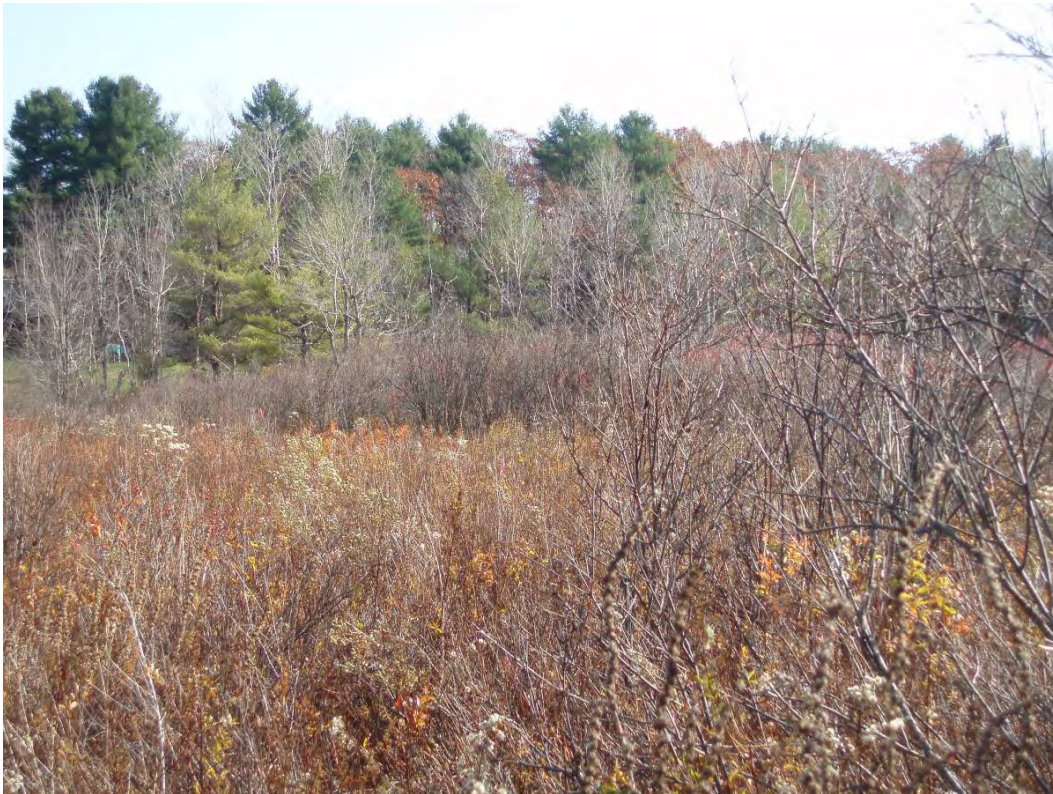
Photo 4. Deciduous shrub swamp community dominated by meadowsweet (foreground) and winterberry-witherod (background) that is located in the upper marsh.

Deciduous shrub swamps are widespread, but occur most frequently and cover larger areas north of Old Bath Road (Photo 4). Meadow sweet was either dominant or a component of the majority of shrub swamps observed in the survey area. Single species observed as dominant in deciduous shrub swamps were meadowsweet and winterberry. Combinations of species dominant in shrub swamps included meadowsweet-winterberry (*Ilex verticillata*); meadowsweet-witherod; meadowsweet-Virginia rose (*rosa virginiana*)-red osier dogwood (*Cornus sericea*), and meadowsweet-witherod-arrowwood.

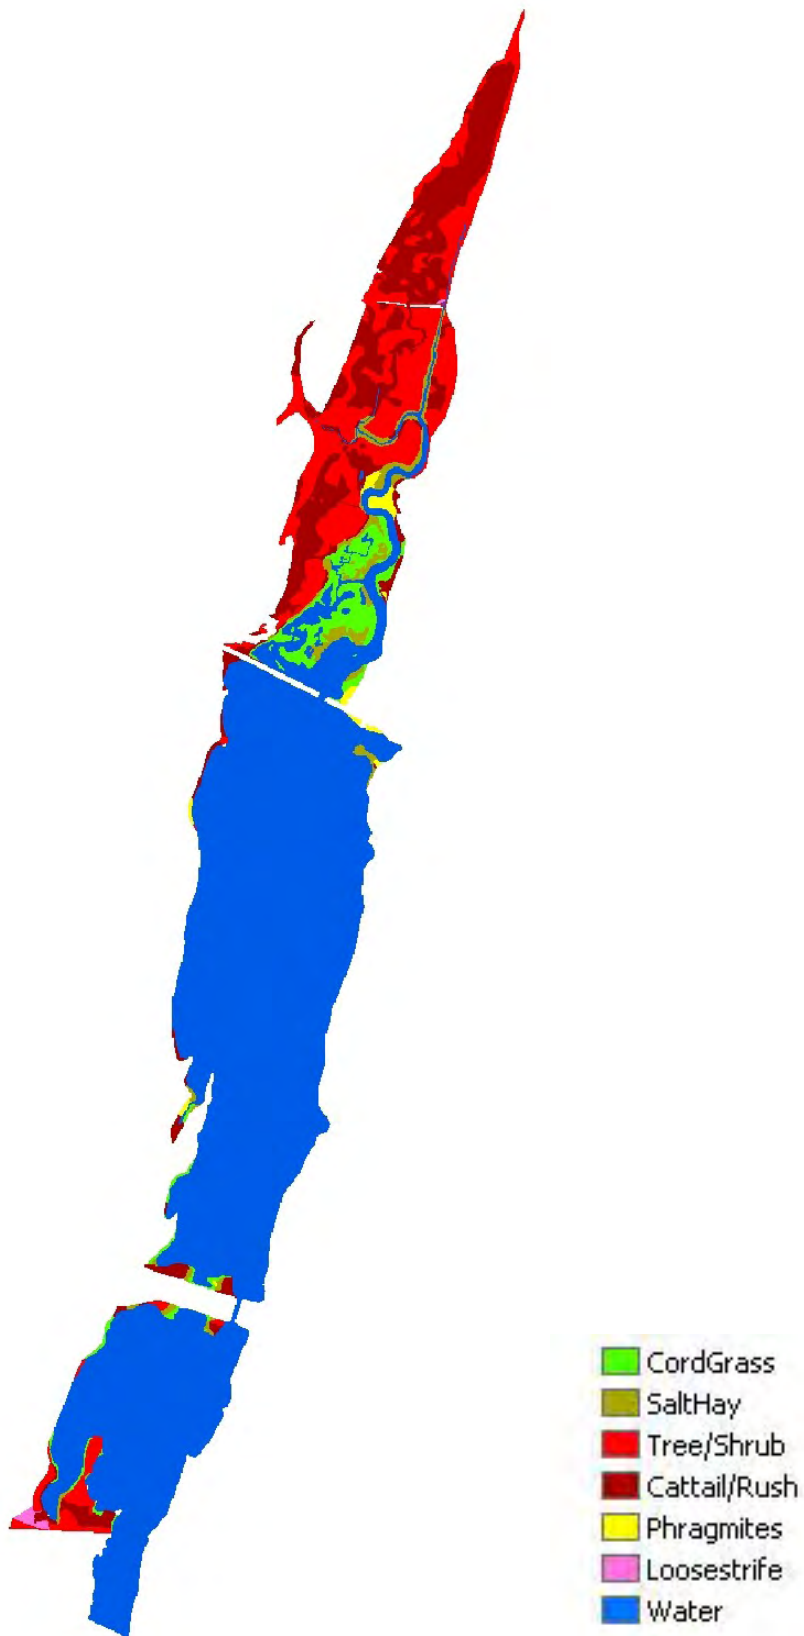
Figure 6. Map Image of Existing Vegetation Covertypes Observed at New Meadows Lake (Fall 2006)

Cover composition of the vegetated portion of the 84-acre marsh (north of Old Bath Road) showed strong dominance by upland and brackish plant species. Figure 6 is a GIS image of the marsh covertype map based on the field survey, including color-coded vegetation covertypes.

The map shows the location of the tidal inflow culvert under Bath Road Causeway at the far south (bottom) of the image. Moving north, the map marks the delineation of the upper and lower lake by the U. S. Route 1 Causeway (large gap in open water with channel). At the top of the image, the map shows the primary vegetation communities of the site, all above Old Bath Road. The upper marsh is approximately 80 acres of the total 84 vegetated acres at the site, with the remainder as fringe marsh along the steeply sloped upper and lower lake shores.

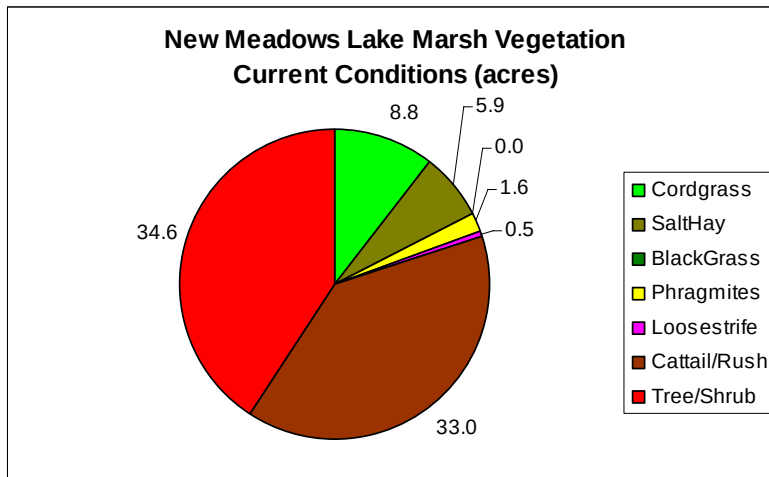
Figure 7. Observed New Meadows Lake Cover Composition in 2006

Figure 7 is a pie chart of existing vegetative covertypes, with 80 percent of vegetated acres either tree/shrub (35 acres of woody species) or cattail/rush (29 acres of cattail [*Typha label*] plus 4 acres of alkali bulrush). Other brackish communities included common reed ("*Phragmites*," 1.6 acres) and purple loosestrife ("*Loosestrife*," 0.5 acres). Salt marsh plant communities were found on only 17 percent of the site, with saltwater cordgrass ("*Cordgrass*") covering 8.8 acres and saltmeadow cordgrass ("*SaltHay*") on 5.9 acres. There were no surveyed vegetation communities dominated by black-grass rush although the species was observed in low abundances, primarily near the boat landing in the upper lake.

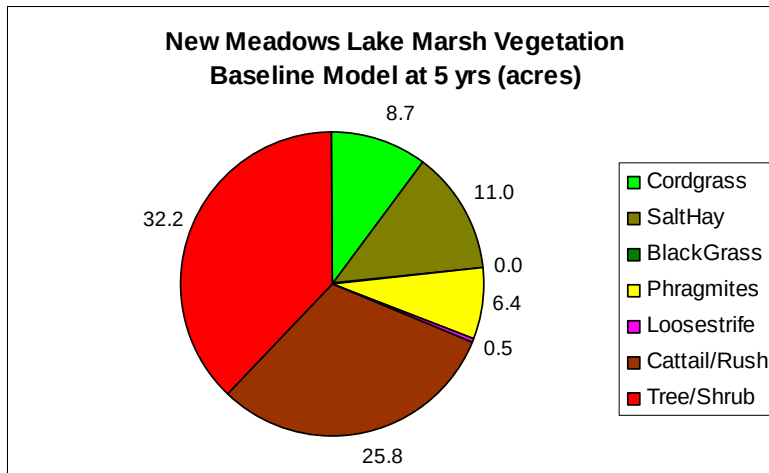
Figure 8. Modeled New Meadows Lake Baseline Cover Composition in Five Years

The model was run for baseline conditions plus three alternatives to show expected outcomes in five years based on varying tidal hydrology. The first model run, with baseline tidal heights from Table 1, showed a similar overall distribution of salt marsh and brackish species in five years (Figure 8). The model predicted some conversion of low lying cattail/rush to salt marsh (+ 5 ac), and four-fold expansion of common reed (+ 4.8 ac) in the upper marsh (Figure 9). Outcomes were generally consistent with seasonal transitions observed at typical New England salt marshes when common reed is present.

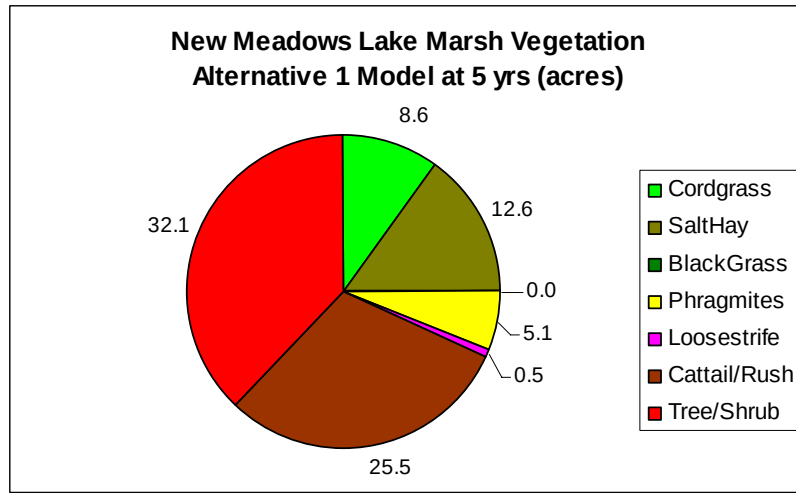
Figure 10. Modeled Alternative 1 Cover Composition in Five Years

Five-year model results for Alternative 1 (culvert expansion and 4.5' lower) produced outcomes similar to the baseline scenario. Modeling indicated that brackish species would continue to dominate the site, and still account for 63.2 acres of vegetated marsh (75%). The model did suggest that saltmeadow cordgrass ("SaltHay") would achieve minor expansion of habitat under this scenario (+ 1.6 ac from baseline). In addition, common reed would be somewhat held in check by the higher tides, as compared to baseline, although still expanding from current conditions. Figure 11 shows a map of model outcomes for Alternative 1.

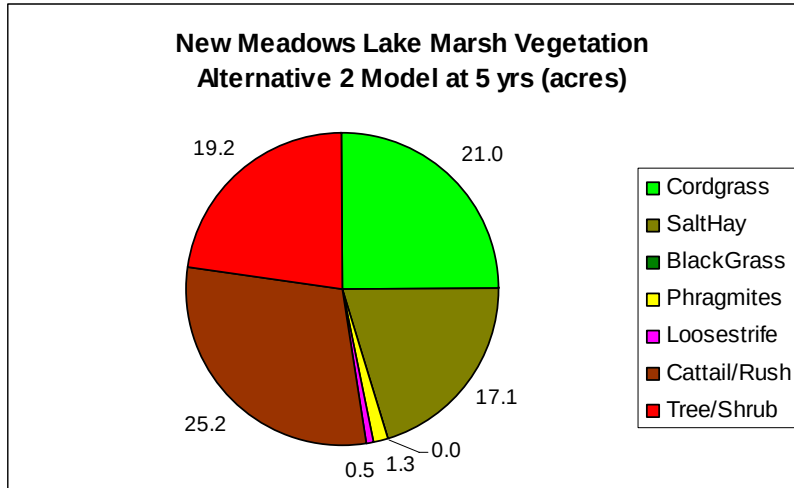
Figure 12. Modeled Alternative 2 Cover Composition in Five Years

Alternative 2 (culvert expansion and 7.5' lower) results indicated a substantial shift toward creation of salt marsh at NML. The model predicted expansion of salt marsh habitat to 38 acres, with gains of both low marsh ("Cordgrass") and high marsh ("SaltHay") species (Figure 12). New salt marsh expansion of about 25 acres is due largely to conversion of tree/shrub areas in the upper marsh. Also, it is expected that the new hydrology would halt the invasion of common reed and reduce this community size from current levels. Figure 13 shows a map of model outcomes for Alternative 2.

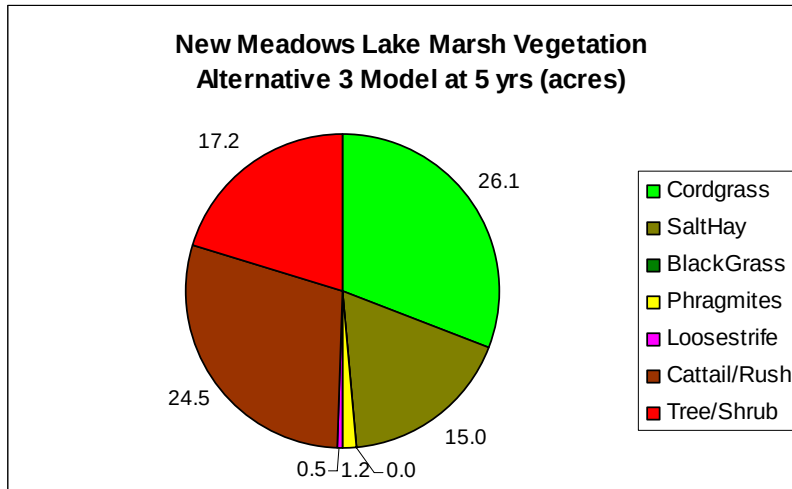
Figure 14. Modeled Alternative 3 Cover Composition in Five Years

Alternative 3 (full restoration) results indicated only slight incremental benefit compared to Alternative 2, with an additional 3 acres of salt marsh expected to be gained (41 total, Figure 14). Alternative 3 modeling suggests that a mix of woody habitats, cattail/rush, and salt marsh species would co-exist at the site even with full restoration. Figure 16 shows a map of model outcomes for Alternative 3.

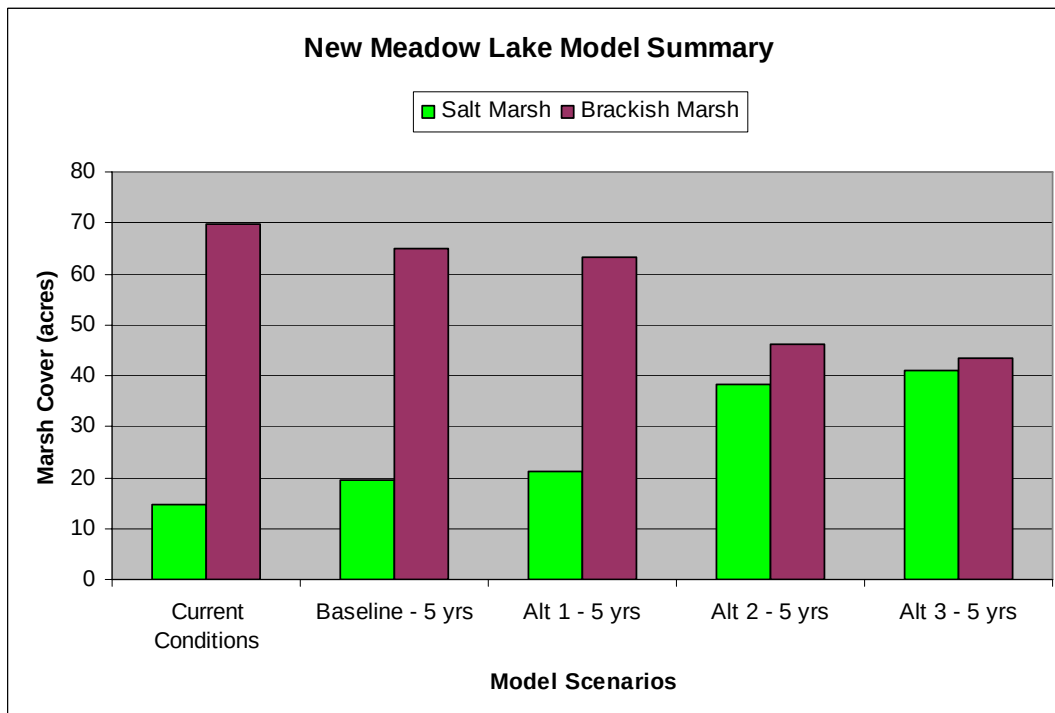
Figure 15. Initial and Modeled Summary Results for New Meadow Lake

As a summary graph, modeled plant community results were combined as salt marsh species (cordgrass, salt hay) or brackish marsh species (cattail/rush, *Phragmites*, loosestrife and trees/shrubs), and presented for initial and modeled outcomes (Figure 15).
