### Casco Bay Watershed

### Fish Barrier Priorities Atlas

#### March 2012

## Casco Bay Barriers by Town

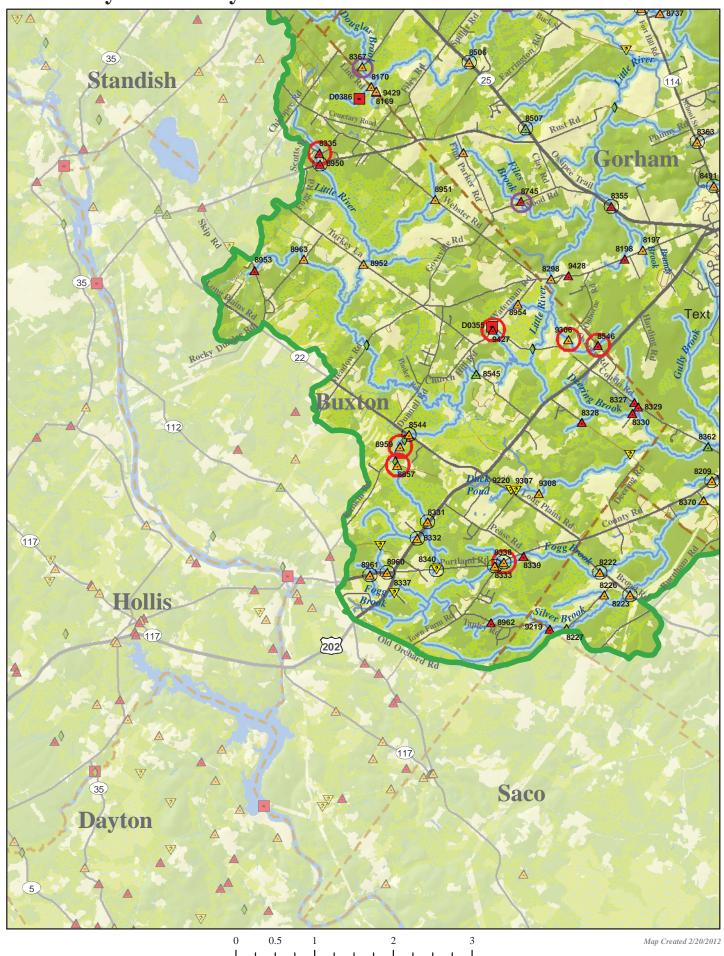
### **Buxton**

Road-stream crossings are shown with SiteID numbers to help identify them in the barrier database. Dams, in most cases, have labels both of SiteID and the dam's common name, if one is known. *Severe* barriers are defined as those road/stream crossings where fundamental physical barriers exist at either the inlet or outlet of the crossing, including inlets or outlets "perched" above the stream channel, and inlets blocked at least 50%, usually by debris. *Potential* barriers cover a wide spectrum of road-stream crossing situations where fish passage problems are likely to exist at some flows for some species or age groups of fish, and passage of other aquatic organisms such as amphibians and macroinvertebrates is likely also limited. Sites that were inaccessible to survey crews, and therefore not surveyed, are shown as unsurveyed, but are included in our analysis as *Potential* barriers. Dams are classified by whether or not they have effective facilities in place to provide upstream fish passage. Natural barriers, including waterfalls, debris jams (including woody debris or rock and fine sediments), and beaver dams were assessed when in close proximity to surveyed crossings and dams, and are mapped as well.

The maps present data from Cumberland County Emergency Management Agency (CCEMA) and CBEP to show where flood hazards are likely to overlap with fish barriers. CCEMA, in cooperation with towns, has identified many road crossings as flood hazards based on past flood events. CCEMA sites are marked by purple circles, and do not always coincide with barrier survey sites because they may be located on intermittent streams or larger rivers crossed by bridges, which are generally passable for fish but may still entail flood hazards.

Habitat	Basic Structure	Barrier	Survey		Road Type &		υτм	υтм	Stream	Number Of		
Site ID	Town	Priority	Type	Class	Date	Road Name	Class	Stream	East	North	Type	Culverts	Material	Condition
8328	Buxton	High	Multiple Culverts	Severe	8/6/2010	Atkinson Rd	Town / Paved	Unknown	380679	4833227	Perennial	2	Plastic	
9306	Buxton	High	Culvert	Potential	7/23/2009	Bowder Rd	Private / Unpaved	Unnamed	380407	4834916	Perennial	1	Metal	
8327	Buxton	High	Culvert	Severe	8/5/2010	Cousins Rd	Town / Paved	Unknown	381757	4833640	Perennial	1	Metal	
8963	Buxton	High	Multiple Culverts	Potential	8/3/2009	Henry Hill Rd	Town / Paved	Unnamed	375003	4836574	Perennial	2	Plastic	
8335	Buxton	High	Culvert	Severe	7/27/2009	Kevin Circle	Town / Paved	Unknown	375320	4838737	Perennial	1	Concrete	
8169	Buxton	High	Culvert	Severe	7/27/2009	Line Rd	Town / Paved	Unknown	376477	4839984	Perennial	1	Metal	
8544	Buxton	High	Multiple Culverts	Potential	6/26/2009	Long Plains Rd	State / Paved	Unnamed	377153	4832984	Perennial	2	Metal

Primary	Crossing						Upstream					
	Specific			Inlet	Structure		Outlet		Fill	Estimated	Miles	Up-	Total	Down-		Hydraulic
	Structure	Inlet	Inlet	Span	Length	Outlet	Drop	Crossing	Height	Stream	to Next	Stream	Upstream	stream		Height
Site ID	Туре	Condition	Blocked	FT	FT	Condition	FT	Substrate	FT	Width FT	Barriers	Barriers	Miles	Barriers	Dam Name	FT
8328	Round Culvert	At Grade	No	2.0	35.8	Perched	0.1	None		9.8	0.229	0	0.229	1		
9306	Round Culvert	At Grade	No	3.0	36.4	At Grade		None		56.1	0.509	1	0.879	3		
8327	Round Culvert	At Grade	No	3.5	45.9	Perched	0.8	None		10.6	0.731	0	0.731	1		
8963	Round Culvert	At Grade	No	5.0	72.8	At Grade		None		16.8	1.056	1	1.174	3		
8335	Round Culvert	At Grade	No	2.5	47.2	Perched/Cascade	1.2	None		8.1	0.273	0	0.273	5		
8169	Round Culvert	At Grade	No	3.1	34.4	Cascade		None		3.6	0.194	0	0.194	7		
8544	Round Culvert	At Grade	No	4.1	65.5	At Grade		None		14.7	0.310	8	5.390	3
