Casco Bay Watershed Fish Barrier Priorities Atlas

February 2012

Background

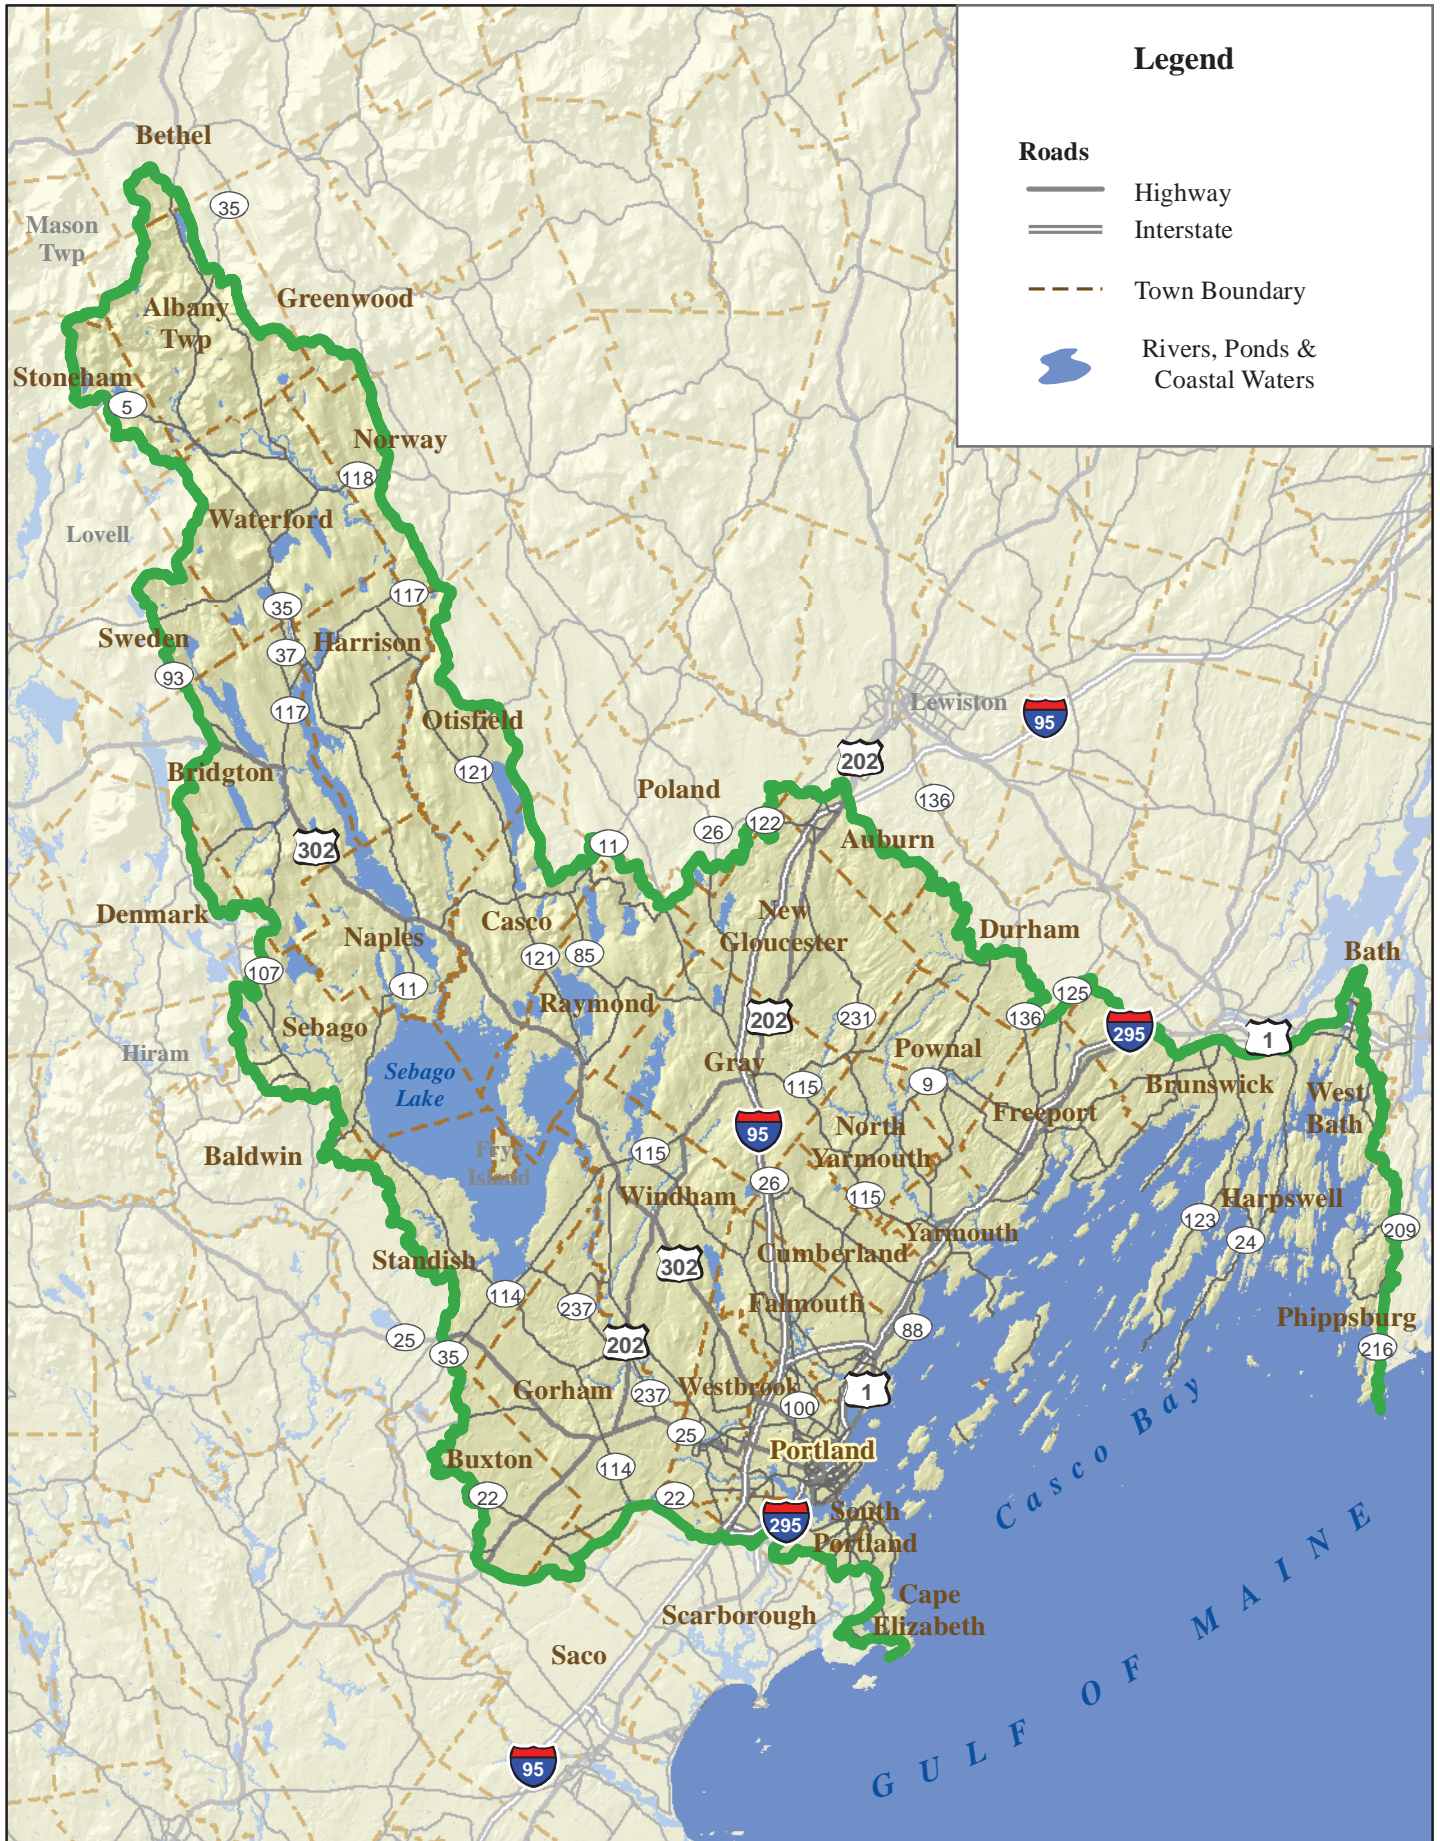
Index Map

Casco Bay Barriers by Town
