Casco Bay Watershed

Fish Barrier Priorities Atlas

March 2012

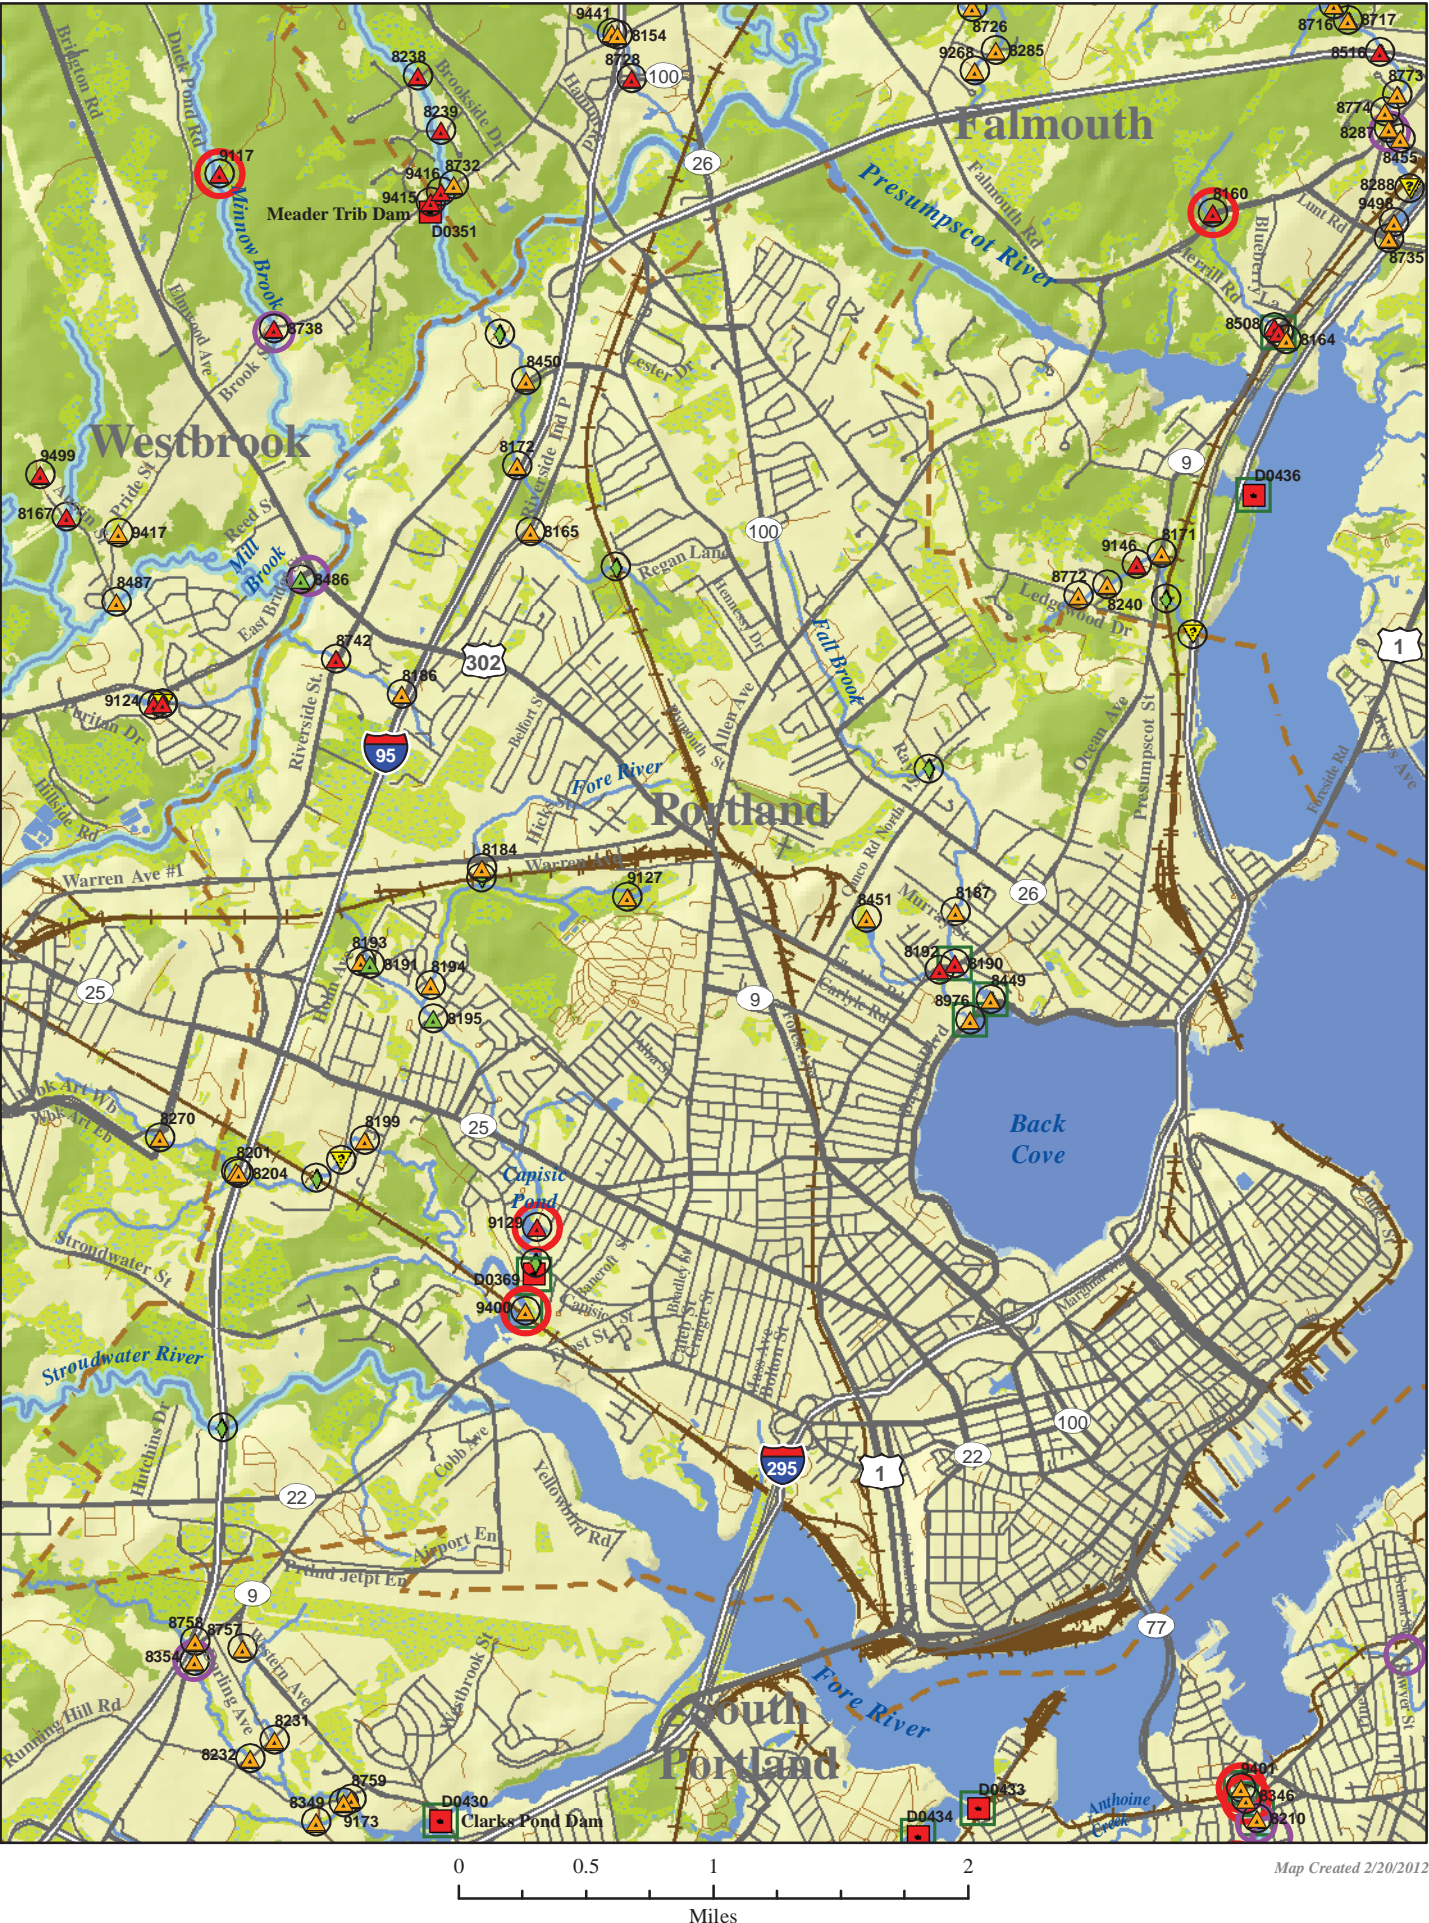
Casco Bay Barriers by Town

Severe and High Priority Potential Barriers by Town

| Site ID | Town | Habitat Priority | Basic Structure Type | Barrier Class | Survey Date | Road Name | Road Type & Class | Stream | UTM East | UTM North | Stream Type | Number Of Culverts | Material | Condition |
| 8190 | Portland | | Multiple Culverts | Severe | 6/3/2009 | Ocean Ave | State / Paved | Fall Brook | 397269 | 4837348 | Tidal | 3 | Concrete | |
| 8192 | Portland | | Culvert | Severe | 6/3/2009 | Ocean Ave | State / Paved | Unknown | 397172 | 4837305 | Perennial | 1 | Concrete | |
| 8742 | Portland | High | Multiple Culverts | Severe | 6/9/2009 | Riverside St | State / Paved | Unknown | 393363 | 4839269 | Perennial | 2 | Metal | |
| 9129 | Portland | | Culvert | Severe | 6/5/2009 | Unnamed | Private / Trail | Fore River | 394631 | 4835683 | Perennial | 1 | Metal | |
| D0369 | Portland | High | Dam | Severe | | | NA | fore river | 394614 | 4835382 | Perennial | | | |
| D0431 | Portland | | Dam | Severe | | | NA | Unknown | 404924 | 4834420 | Tidal | | | |
