## **Preliminary Summary of Existing Biological Monitoring Data from Capisic Brook in Portland, ME**

1/20/2004

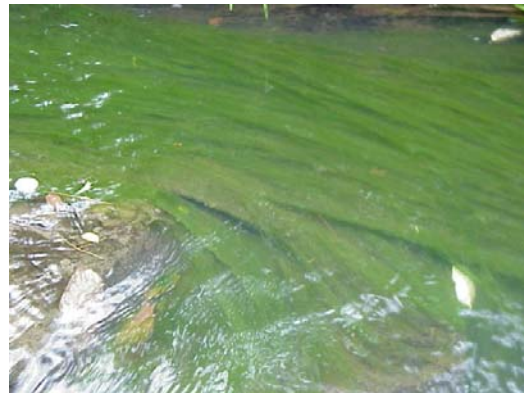
Fig. 6. Algae at downstream station in Capisic Brook on July 9, 2003

Water temperature during the summer months was quite high (see below, Fig. 7), leading to a reduction in the DO carrying capacity of stream water. Excessive algal growth was observed in July when the entire stream bed was covered by a thick mat of green filamentous algae (Fig. 6). An analysis of water flow patterns at this station (see below, Fig. 8) showed that the flow regime is homogeneous with a very low velocity, basically eliminating any possibility for re-aeration of the water. And chemical analysis

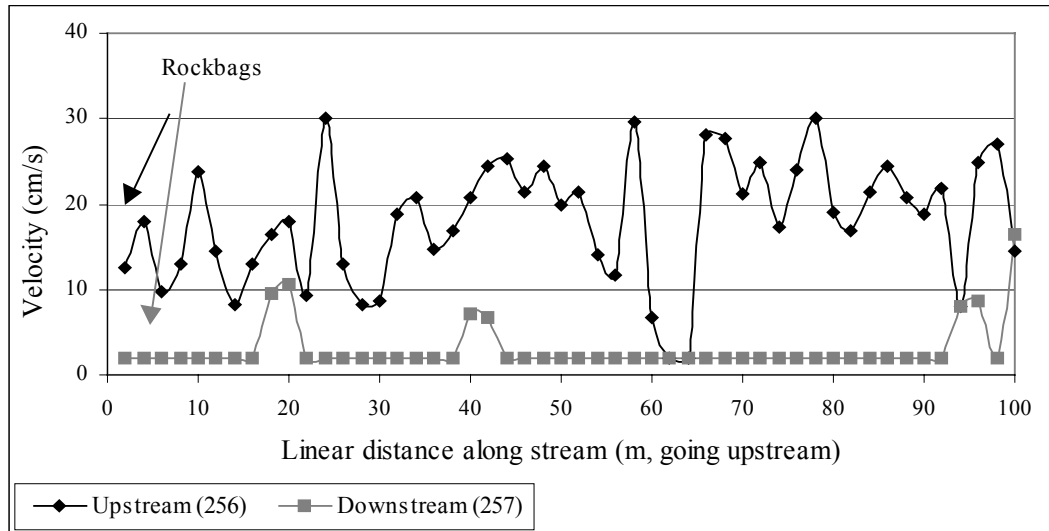
Fig. 8. Variability of flow velocity in Capisic Brook

1. The flow regime at the upstream station in Capisic Brook was highly variable, with velocities ranging from approximately 1 cm/s to 31 cm/s (Fig. 8). At the downstream station, very little flow was measured, with velocities ranging from non-detectable (graphed as ~1 cm/s) to ~11 cm/s (Fig. 8).

The variable flow regime found above the upstream station is another positive feature of this stretch of the stream as it provides aquatic organisms with a wide variety of environments to occupy, thus increasing the potential for a diverse biological community.

In contrast, the homogeneous flow regime found above the downstream station on Capisic Brook does not favor a diverse biological community because organisms requiring relatively swift flows, for example for feeding, will be absent in this environment. Furthermore, a slow flow regime promotes the accumulation of fine sediment on the stream bed which can smother organisms or make feeding structures such as the nets of some caddisflies ineffective. Finally, fast flowing areas in small streams are usually associated with miniature ‘waterfalls’ or riffles where the water tumbles over rocks, which contributes to a re-aeration of the water with dissolved oxygen. As shown above (Water quality monitoring, Continuous dissolved oxygen measurements), dissolved oxygen was identified as a likely factor impacting macroinvertebrate communities at the downstream station.

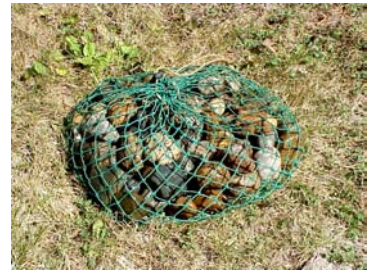
Fig. 11. Rockbag

1. Macroinvertebrate samples collected from rockbags in August after an exposure period of four weeks in the stream have not yet been sorted to separate animals from debris (pieces of wood, leaves, grasses, sand, etc.). Observations during rockbag retrieval at the downstream station indicated a degraded community with the sample consisting mostly of the tolerant organisms amphipods, isopods, snails and some leeches. At the upstream station, samples contained a large amount of debris and sand and it was impossible to estimate community composition. Once sorted, the samples will be identified by a macroinvertebrate taxonomist, whose list of the exact numbers and types of organisms identified is expected in late winter/early spring of 2004. These samples will then be analyzed statistically by the MDEP to aid in determination of water quality conditions.
