Tidal Restriction Restoration at Wallace Shore Road

2016 Monitoring Report:
Year 2 of 5, Post-Project

<u>Project Name:</u>	Tidal Restriction Restoration at Wallace Shore Road
<u>MNRC ID:</u>	2013-CIM-Wallace Shore Rd-CBEP
<u>Project Location:</u>	Appletree Marsh, Harpswell
<u>Project Sponsor:</u>	Casco Bay Estuary Partnership (CBEP)
<u>Contractor and/or Consultant:</u>	Shaw Brothers Construction; Wright Pierce
<u>Start and Completion Dates:</u>	12/15/2014 – 12/29/2014.
<u>Corps and DEP Permit Numbers:</u>	Corps Permit #: NAE-2014-01922; State ID#: NRPA/PBR #58778

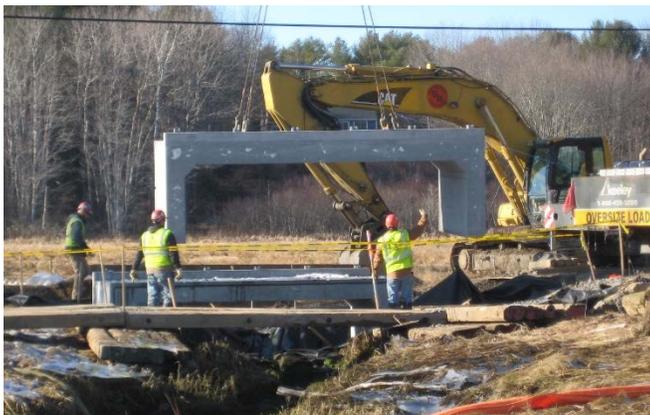
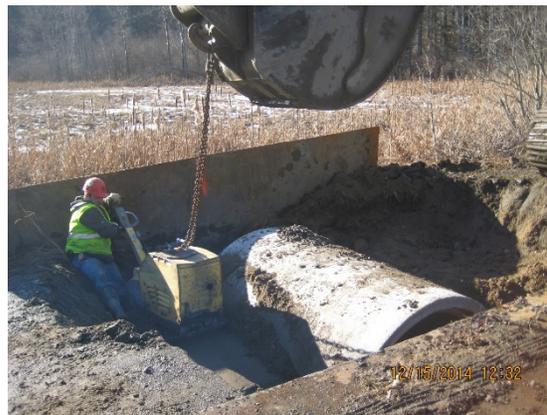
Figure 1. Installation of open bottom concrete box culvert IN December 2014 at the lower site (9079, left) and embedded concrete round pipe at the upper site (9078, right).

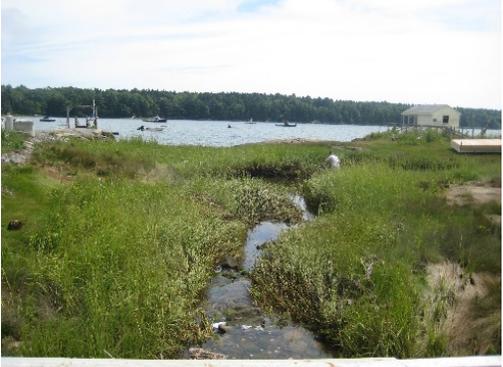
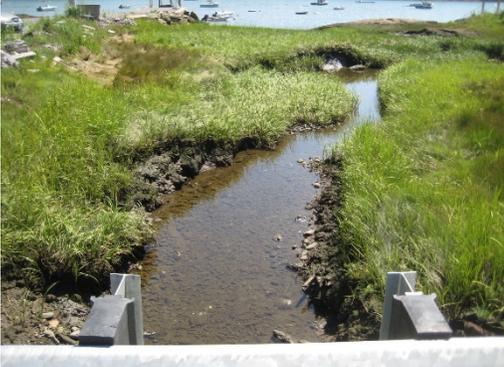
SITE 9079, PRE-PROJECT	SITE 9079, POST-PROJECT
View Downstream (Est). Dates (L to R): 7/31/2012; 7/26/2016.

Table 11. Photos of project area, crossing #9079 (crossing nearest to bay). Photos reflect conditions at low tide.

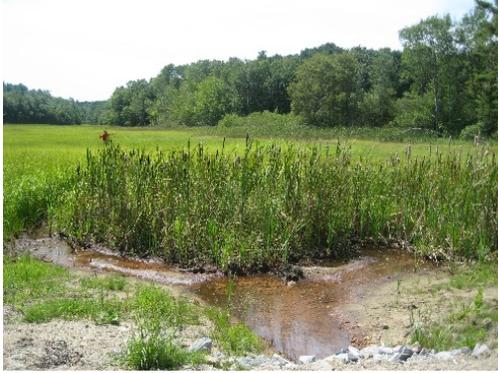
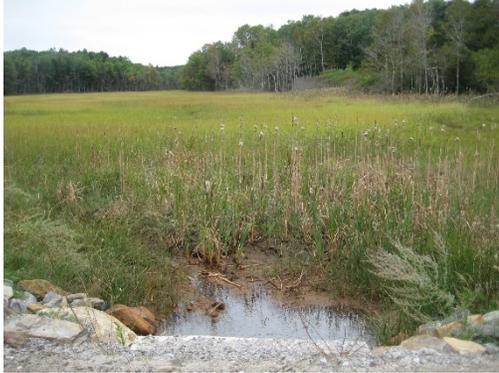
SITE 9078, PRE-PROJECT	SITE 9078, POST-PROJECT
View Downstream (South). Dates (L to R): 7/23/2012; 9/8/2016

Table 12. Photos of project area, crossing #9078 (crossing nearest to upland). Photos reflect conditions at low tide.

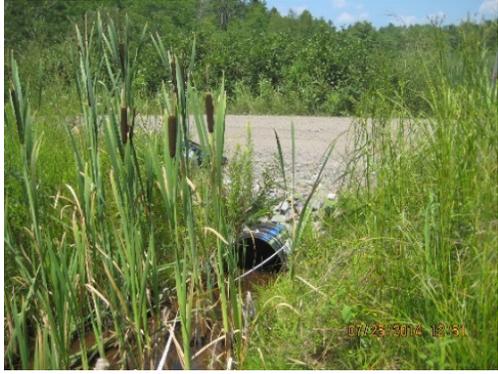
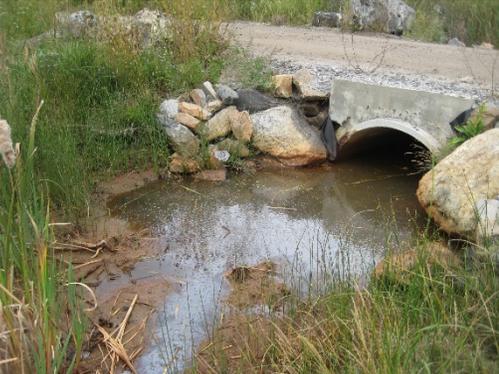
View to Outlet (North). Dates (L to R): 7/28/2014; 9/8/2016

Immediately upstream of Station 9 at the outlet of 9078 (see photos, Appendix A), individual cattails were extremely stressed or dead in 2016, consistent with the absence of glycophytes at Station 9. An abrupt transition in community composition remains evident between Stations 9 downstream of 9078, which has an abundance of halophytic vegetation, and 10 upstream of 9079, which lacks halophytes. However, the relative abundance of glycophytes decreased from 63% in 2015 to just 11% in 2016. This shift was accompanied by a decline in species richness within the surveyed plots from 27 species in 2014 and 2015 to 5 in 2016. This shift in species composition is illustrated in Figure 4 (right), which breaks out *Typha* species from other glycophytic and brackish species observed within the 2016 plots. The graph illustrates that diversity in this area has been lost, and the vast majority of remaining plants are cattails.

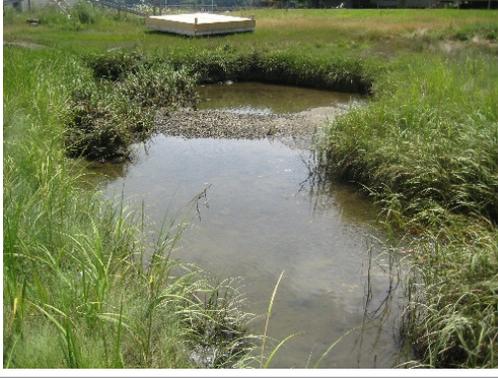
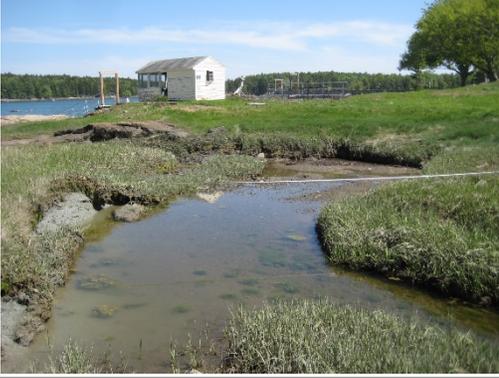
PRE-PROJECT	POST-PROJECT
Station 1 (L – 7/31/2012; R – 5/31/16); view to E/SE. Outlet to bay in the background.

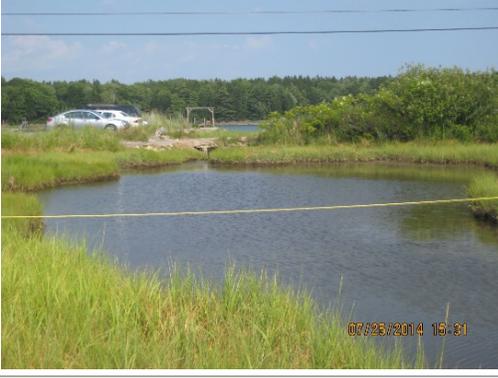
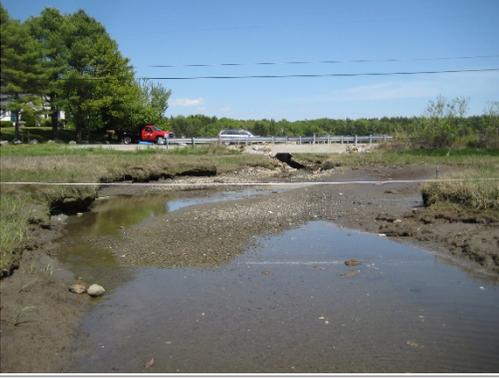
Station 2 (L - 7/25/2014; R – 5/31/16); view to E. Inlet of 9079 in background.

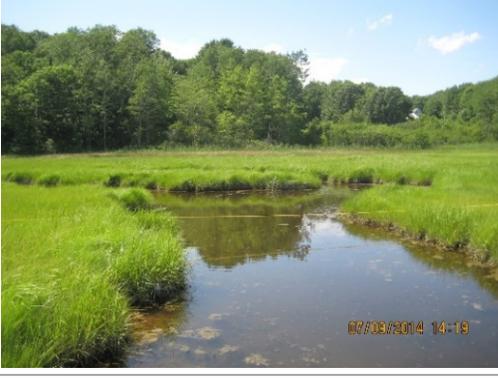
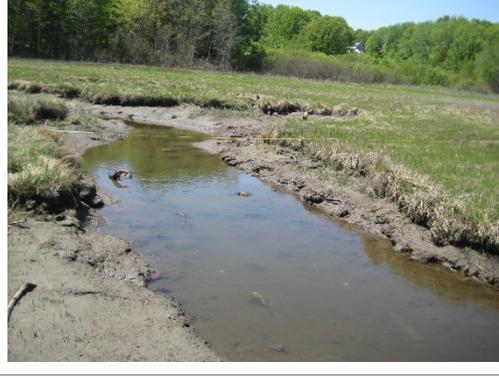
Station 3 (L – 7/9/2014; R – 5/31/16); view to W, looking upstream from 9079.

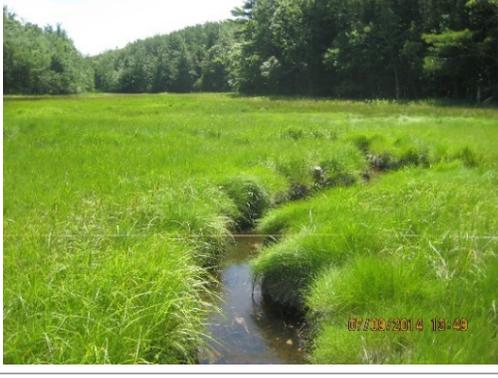
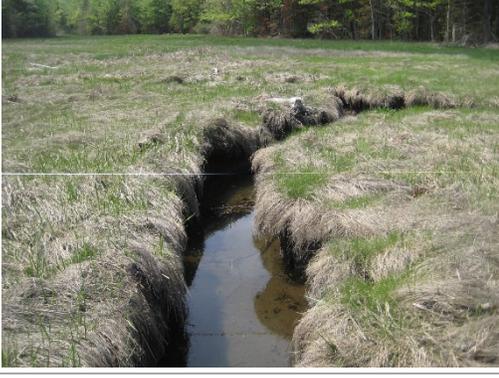
Station 4 (L – 7/9/2014; R – 5/31/16); view to S, toward St. 5, 6, and 7.

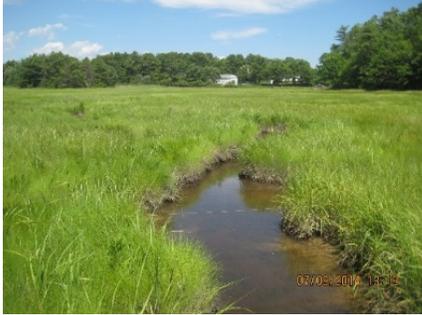
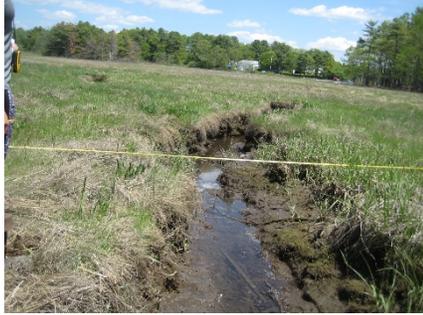
PRE-PROJECT	POST-PROJECT
Station 5 (L – 7/9/2014; R – 5/31/16); view to N, toward St. 4.

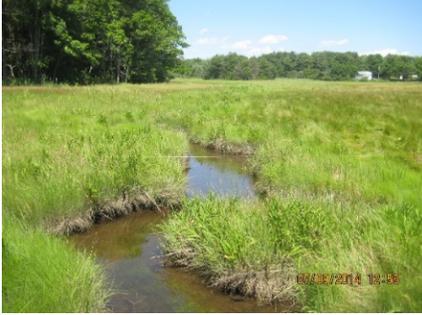
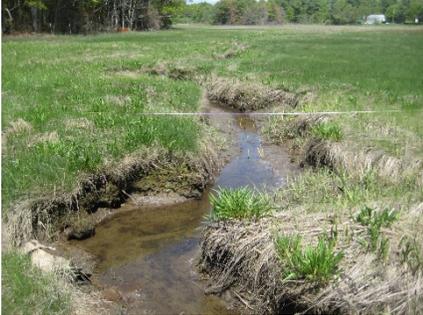
Station 6 (L – 7/9/2014; R – 5/31/16); view to N, toward St. 4 & 5.

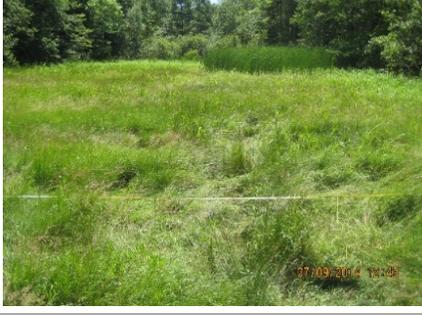
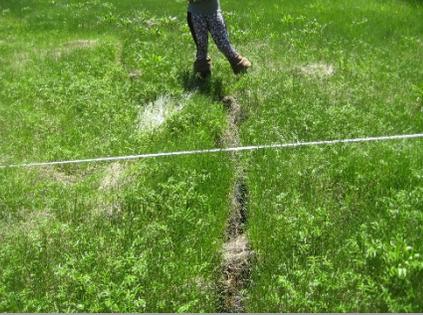
Station 7 (L – 7/9/2014; R – 5/31/16); view to S. Channel obscured by vegetation.

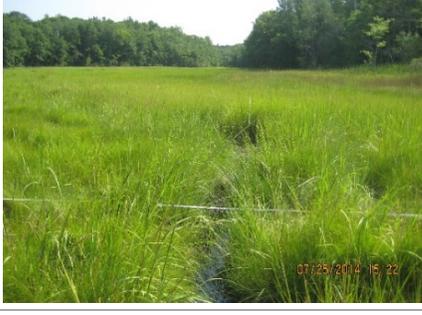
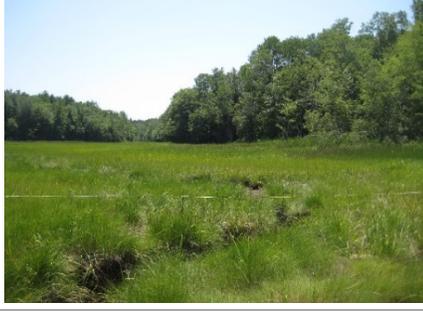
Station 8 (L – 7/25/2014; R – 5/31/16); view to S toward St. 4, 5.

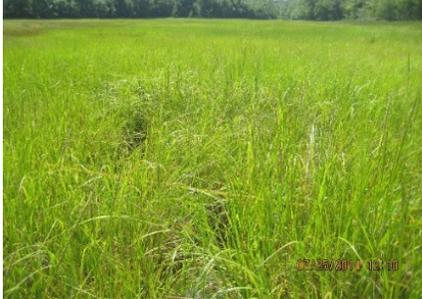
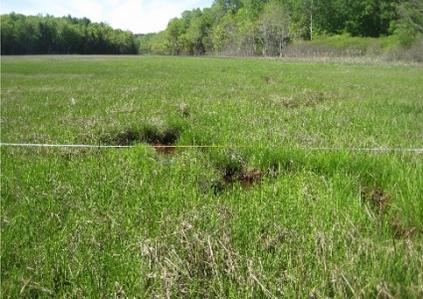
Station 9 (L – 7/25/2014; R – 5/31/16); view to S toward St. 8. Channel obscured by <i>S. alterniflora</i> .
